Samish Island Conservation Area Restoration

# Feasibility Study and Conceptual Restoration Ideas Report

January 2025

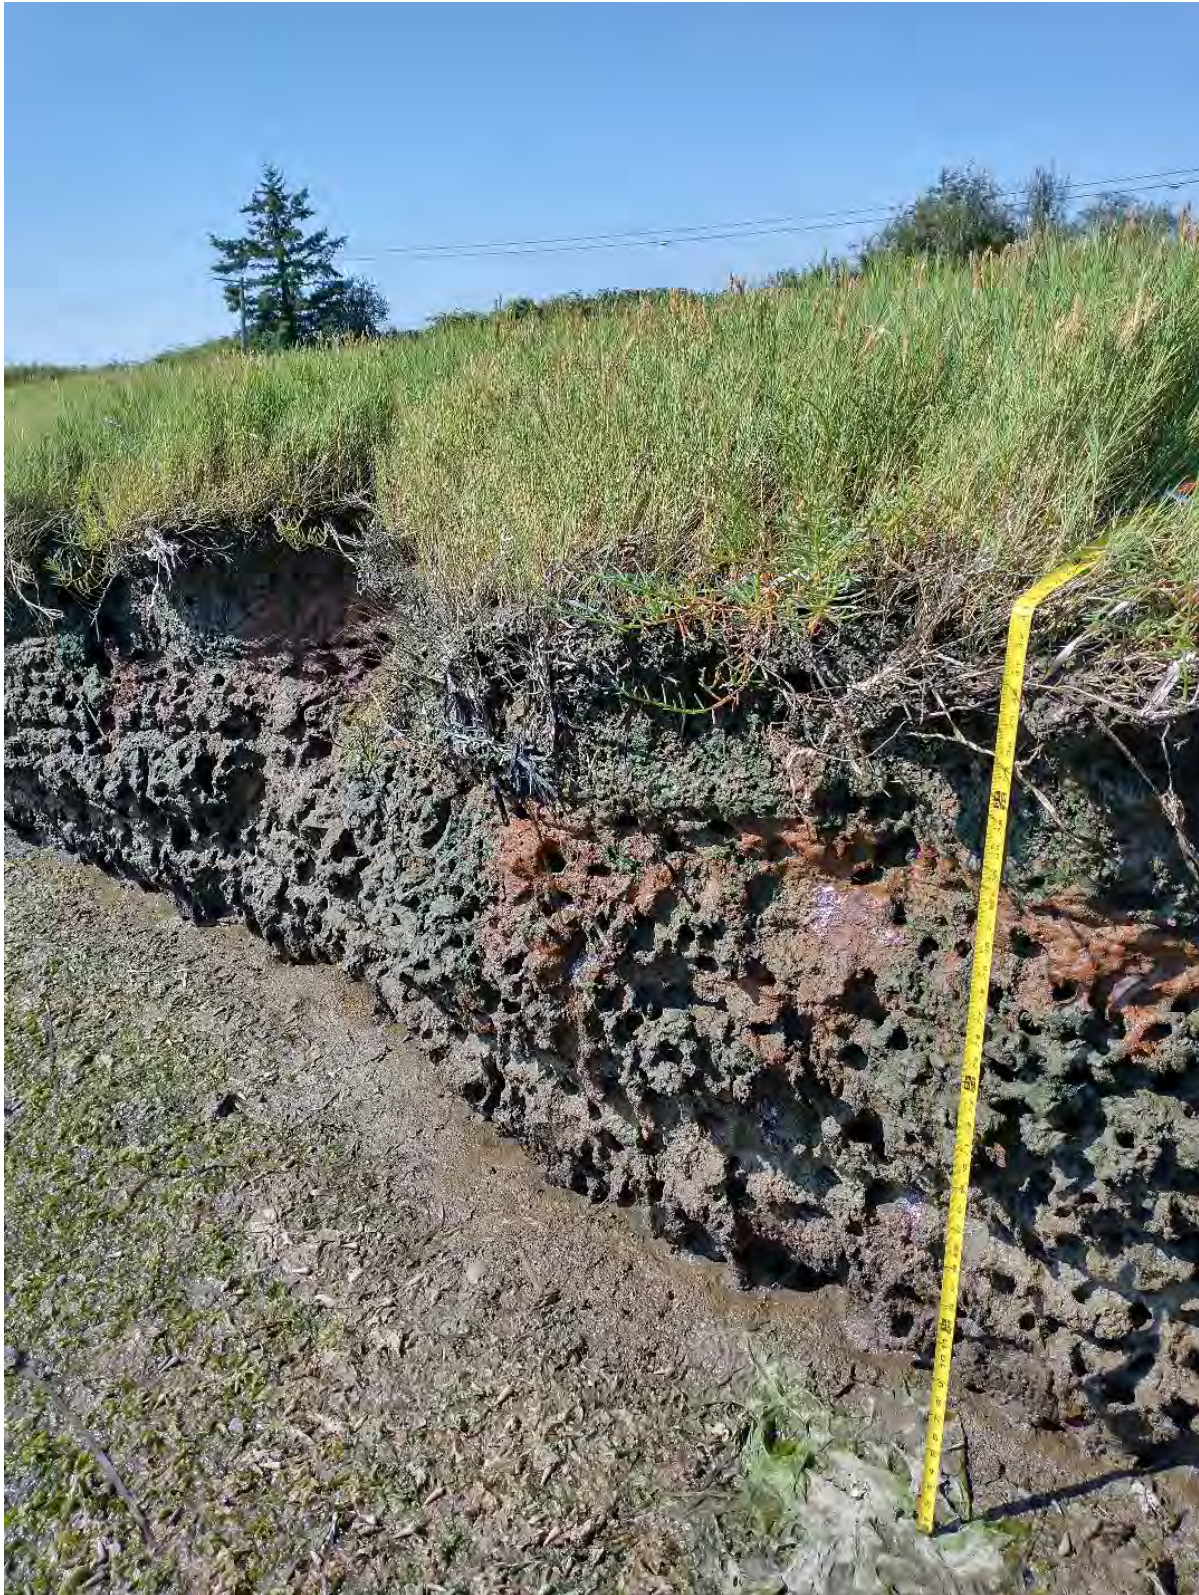
**Figure A-3. Scarp along salt marsh on eastern shoreline (July 2022 photo).**

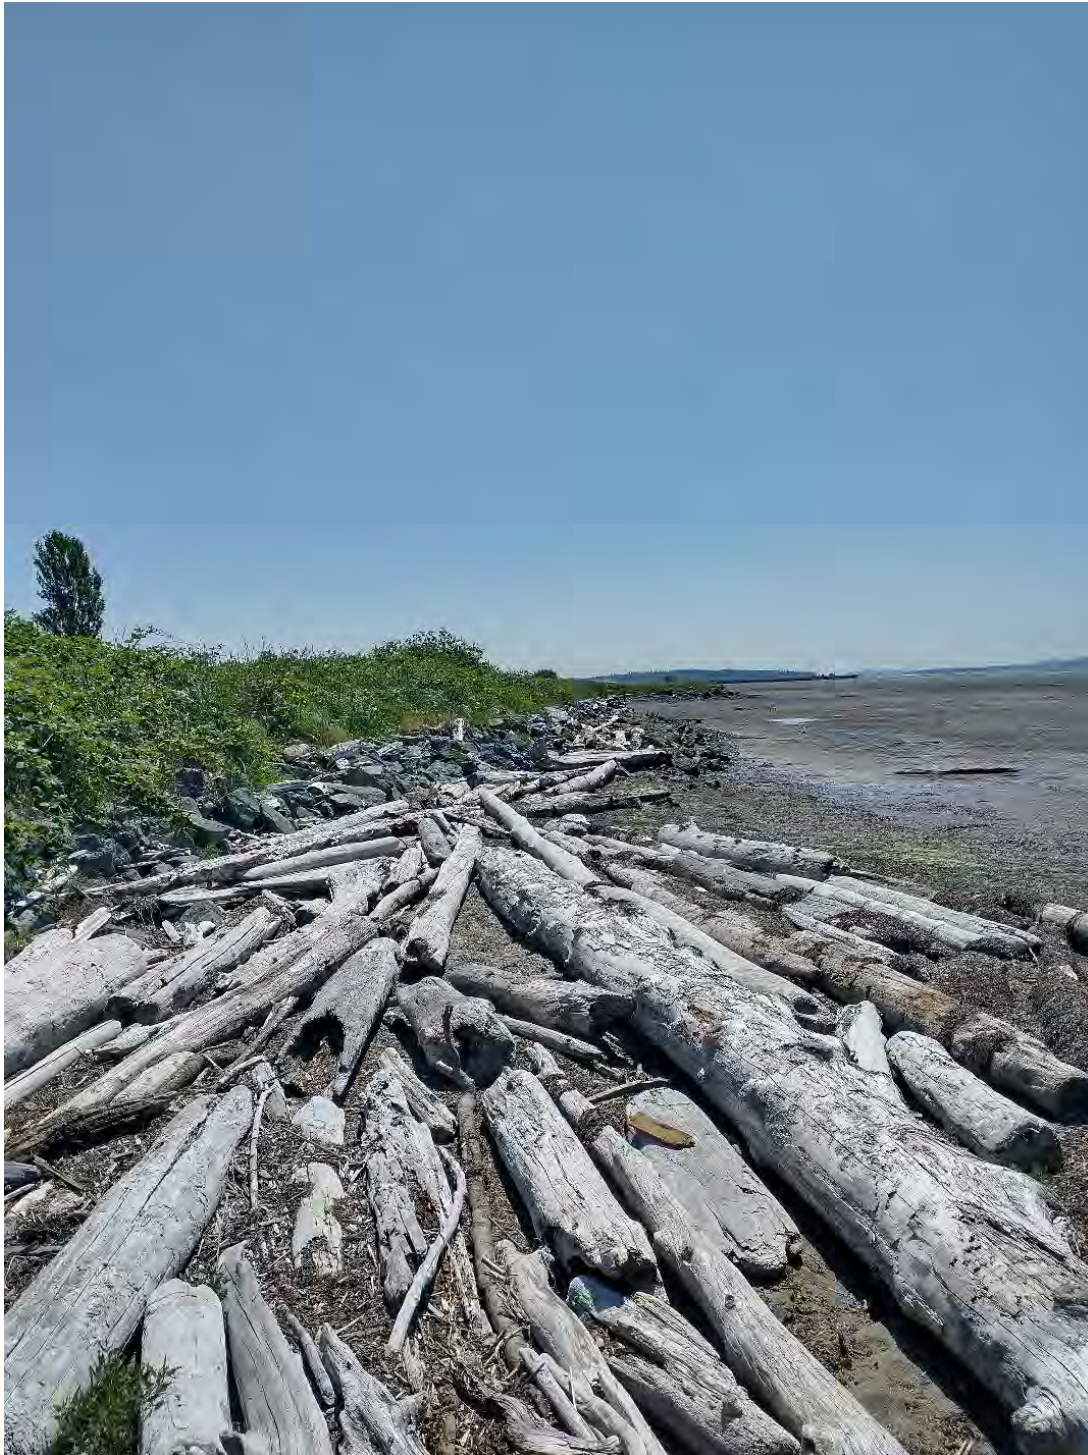
**Figure A-11. Rock armoring and wood accumulation along the western shoreline (July 2022 photo).**

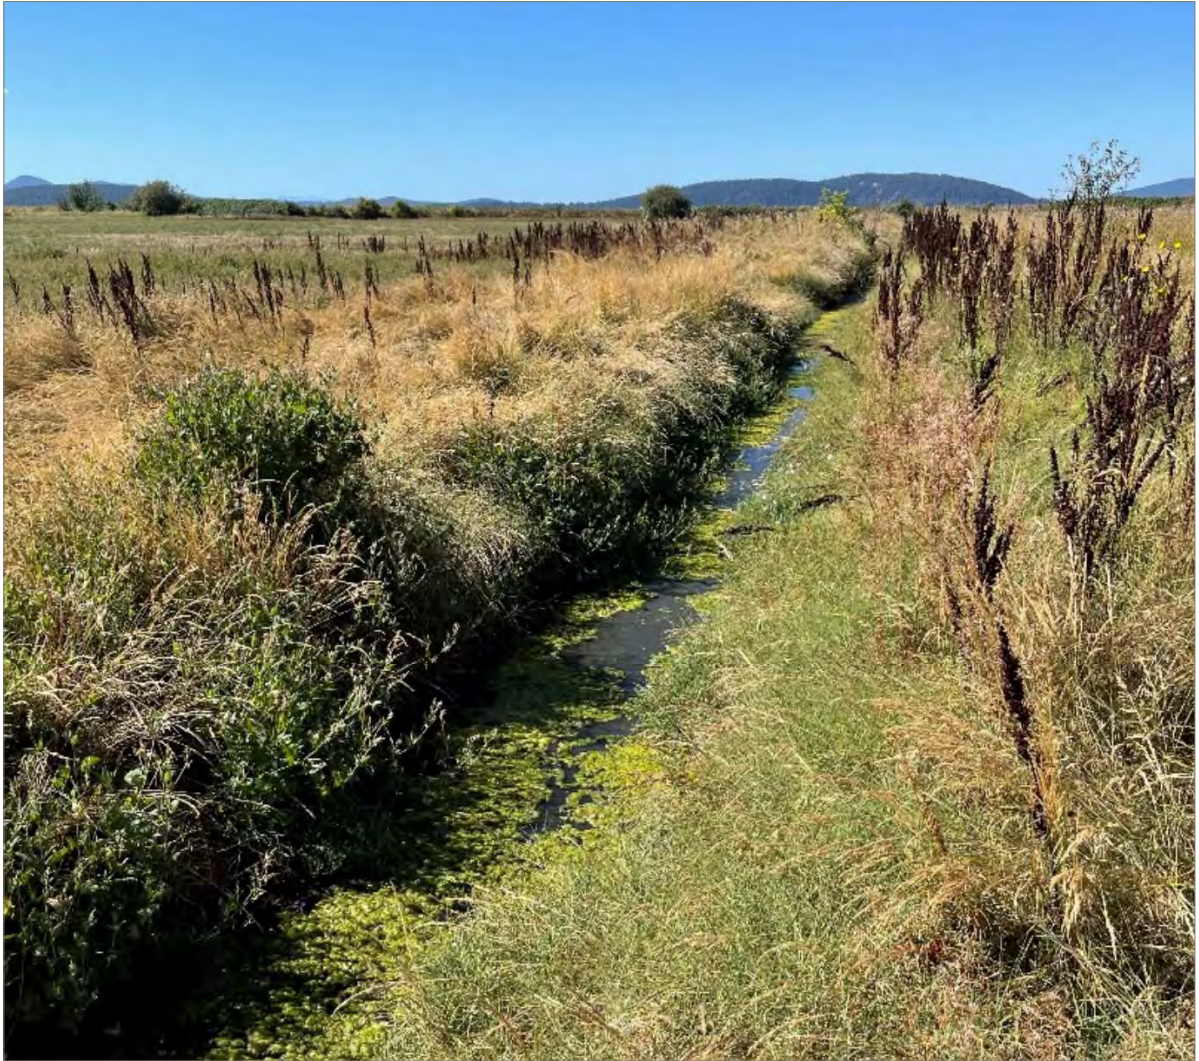
There is a wetted ditch approximately 6 feet wide along the southern boundary of Parcel P47496. The ditch is shown in Exhibit 3-1. At the time of our site visits, there were areas of standing ponded water across the site.

**Exhibit 3-1: Wetted Ditch, Approximately 6 Feet Wide**

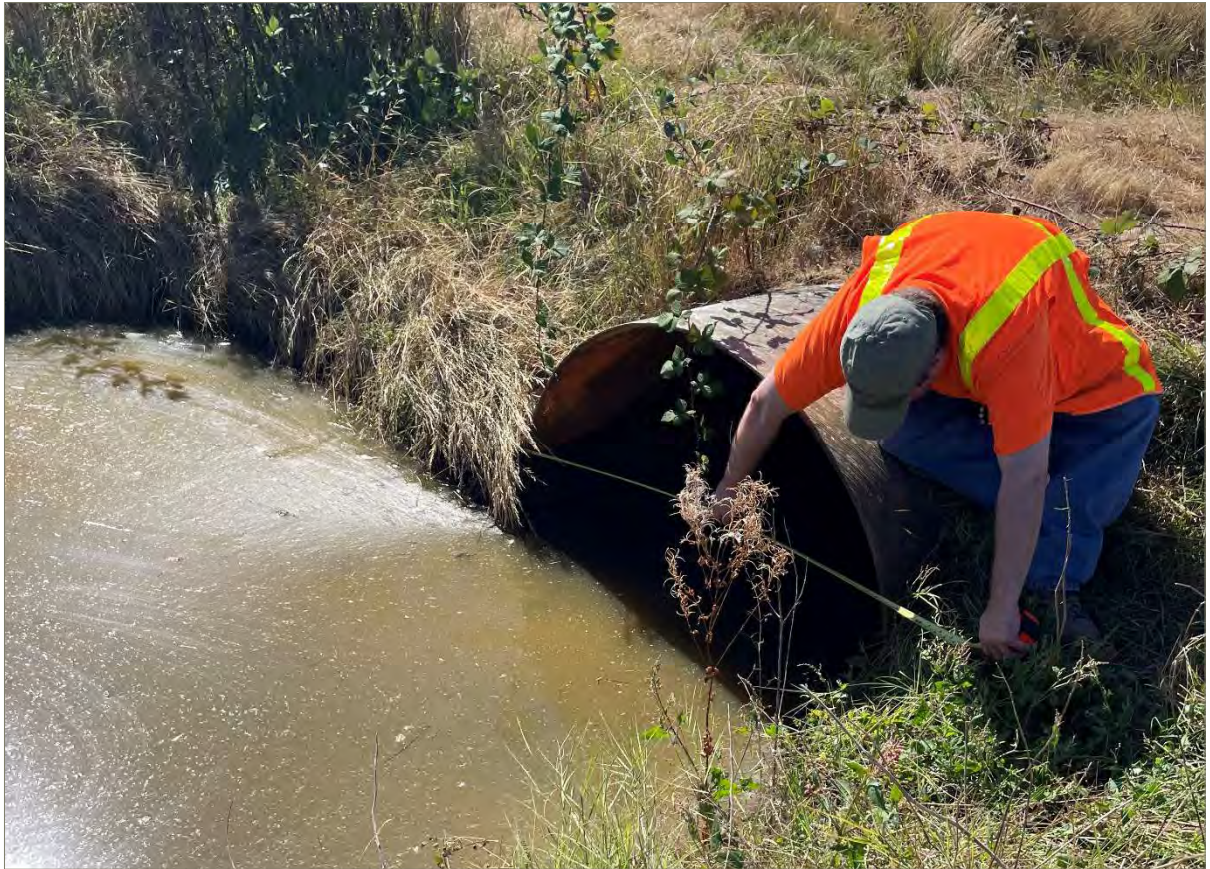
We observed three culverts at the site (shown in Figures 2A and 2B at Points A, B, and C). The culverts at Points A and C were heavily vegetated, and we were unable to inspect the conditions of the culvert. The culvert at Point B is comprised of wood and is made of three sections totaling approximately 17 feet in length. The culvert is approximately 4.5 feet in diameter, and we measured 3 feet and 9 inches from the top of the culvert to the sludge beneath the water surface. The interior of the culvert appeared to be in good condition, although the top of the culvert was exposed and cracking on the western end. Exhibit 3-2 shows the culvert at Point B.

**Exhibit 3-2: Culvert at GPS Point B**

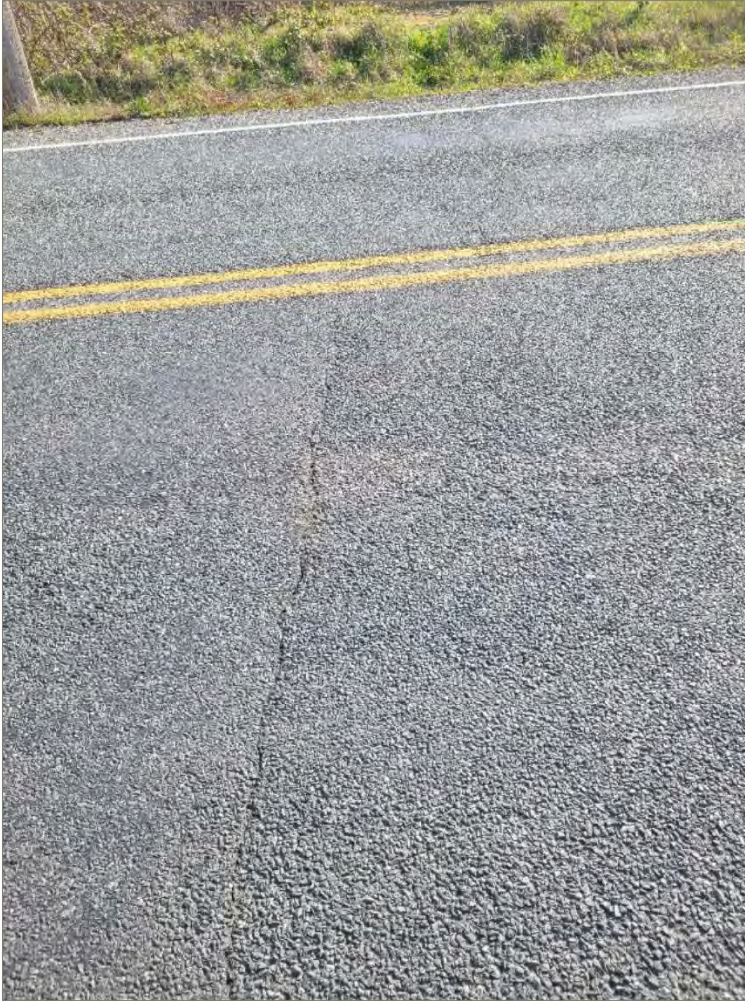
Approximately ¼-inch-wide longitudinal cracks were observed along the length of the road. The cracks typically range from 4 to 15 feet long. Most of the cracks run along the road alignment and are in the southbound lane. Towards the northern end of the site, we noticed more longitudinal cracks and some transverse cracks, shown in Exhibit 3-3, that extended across the southbound and northbound lanes of Samish Island Road. Longitudinal and transverse cracking are not typically load-related failures and can form due to poorly constructed joints, shrinkage of the asphalt, and the reflective cracking from an underlying layer.

**Exhibit 3-3: Transverse Crack in Samish Island Road**

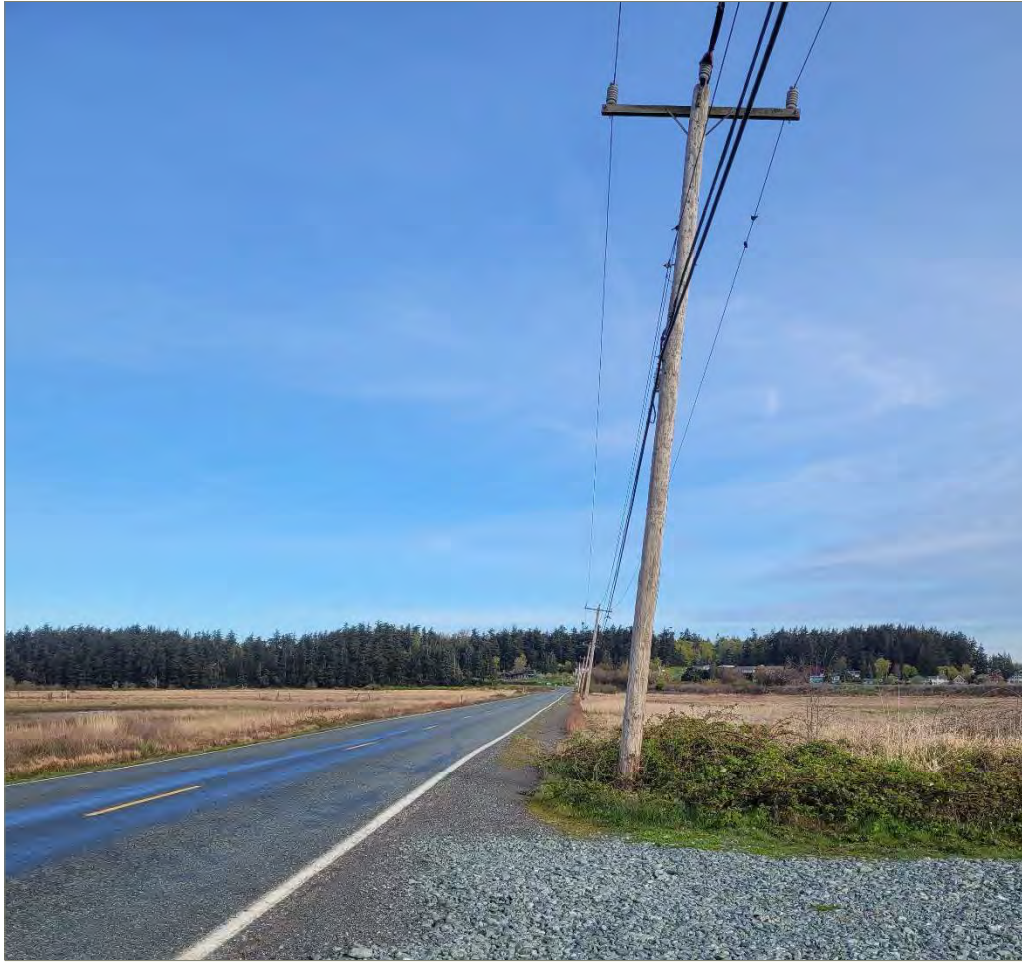
We noticed fewer cracks within the northbound lane of Samish Island Road, and the asphalt pavement appears to be in better condition. The utility poles along the southern portion of the road lean towards the east, as shown in Exhibit 3-4. The leaning utility pole locations are shown in Figures 2A and 2B.

**Exhibit 3-4: Leaning Utility Pole, Looking North**

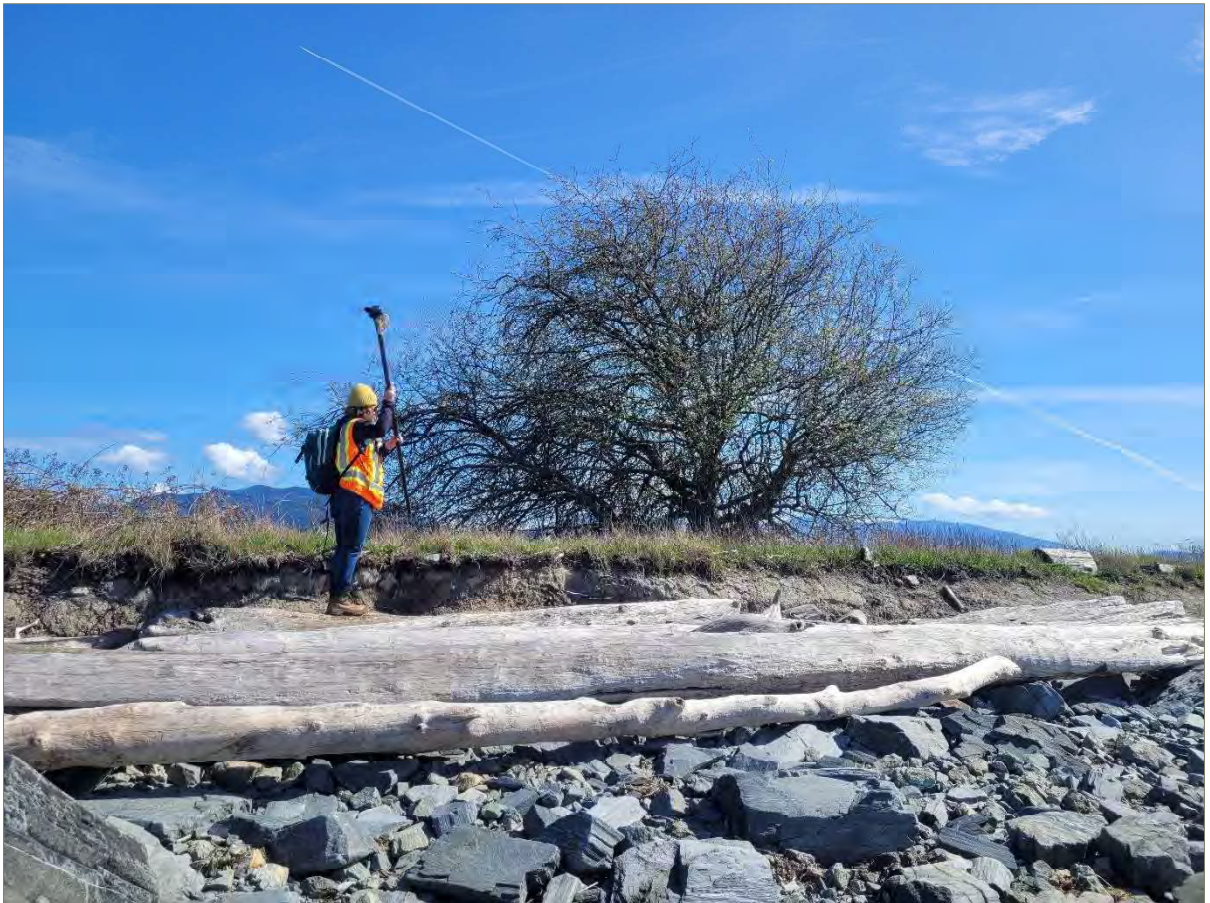
Along the southern portion of the dike, we observed driftwood along the waterward face and dike crest. It is not clear whether the driftwood was placed as part of the dike armoring or accumulated naturally. The landward side is covered with dune grass and there is a ditch running along the edge of the dike. At different segments, the crest of the dike is overgrown with blackberries. Exhibit 3-5 shows some of the driftwood documented during the site reconnaissance.

**Exhibit 3-5: Driftwood Along Dike**

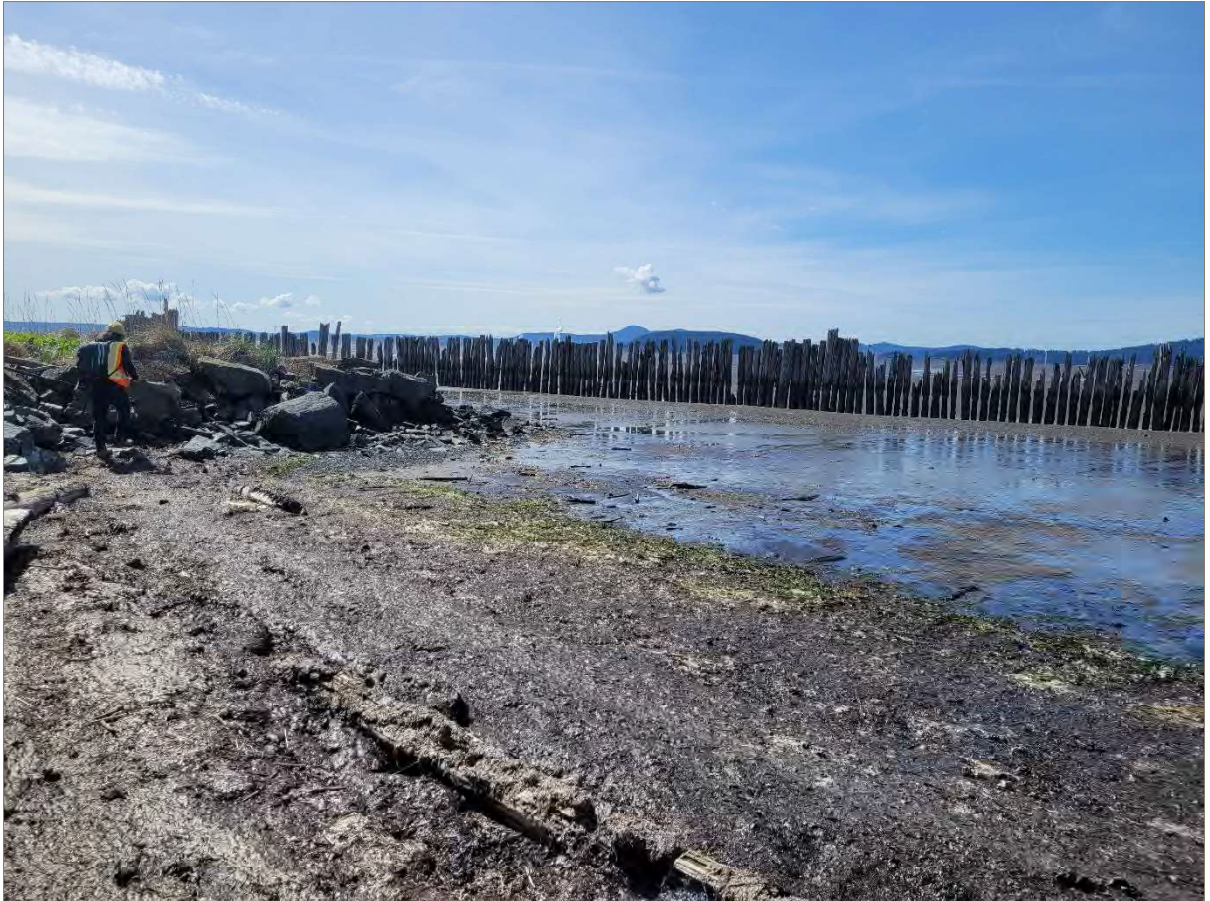
We noticed a row of timber piles, a possible pile dike, placed offshore from the dike starting from Point R and extending southward, shown in Exhibit 3-6. The piling is approximately 40 to 100 feet from the waterward face of the dike. At Point Q, we noticed a culvert on the landward side of the dike but were unable to locate the culvert opening on the waterward side. The end of the Project area is at Point S.

**Exhibit 3-6: Timber Piling, Looking West**

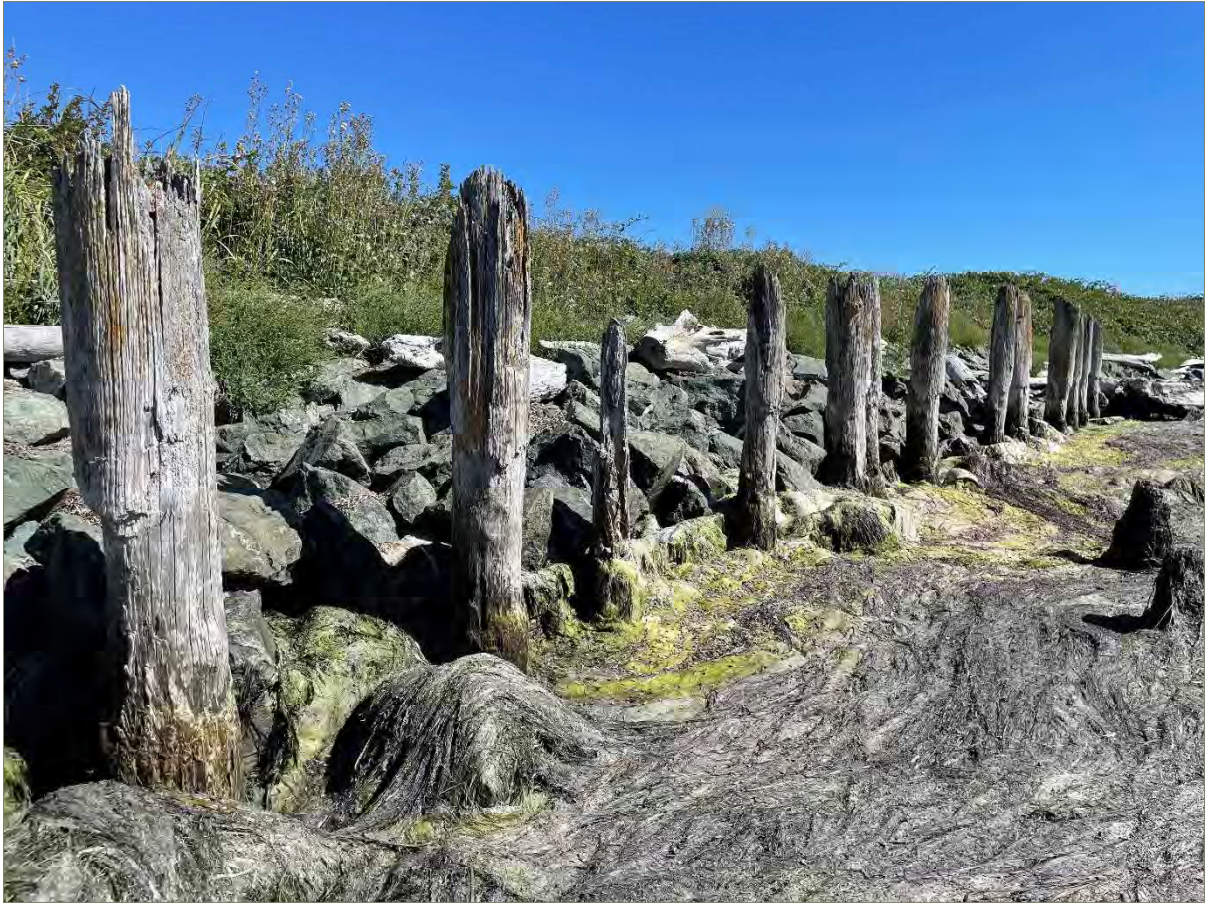
**Exhibit 3-7: Piling Supporting Riprap**

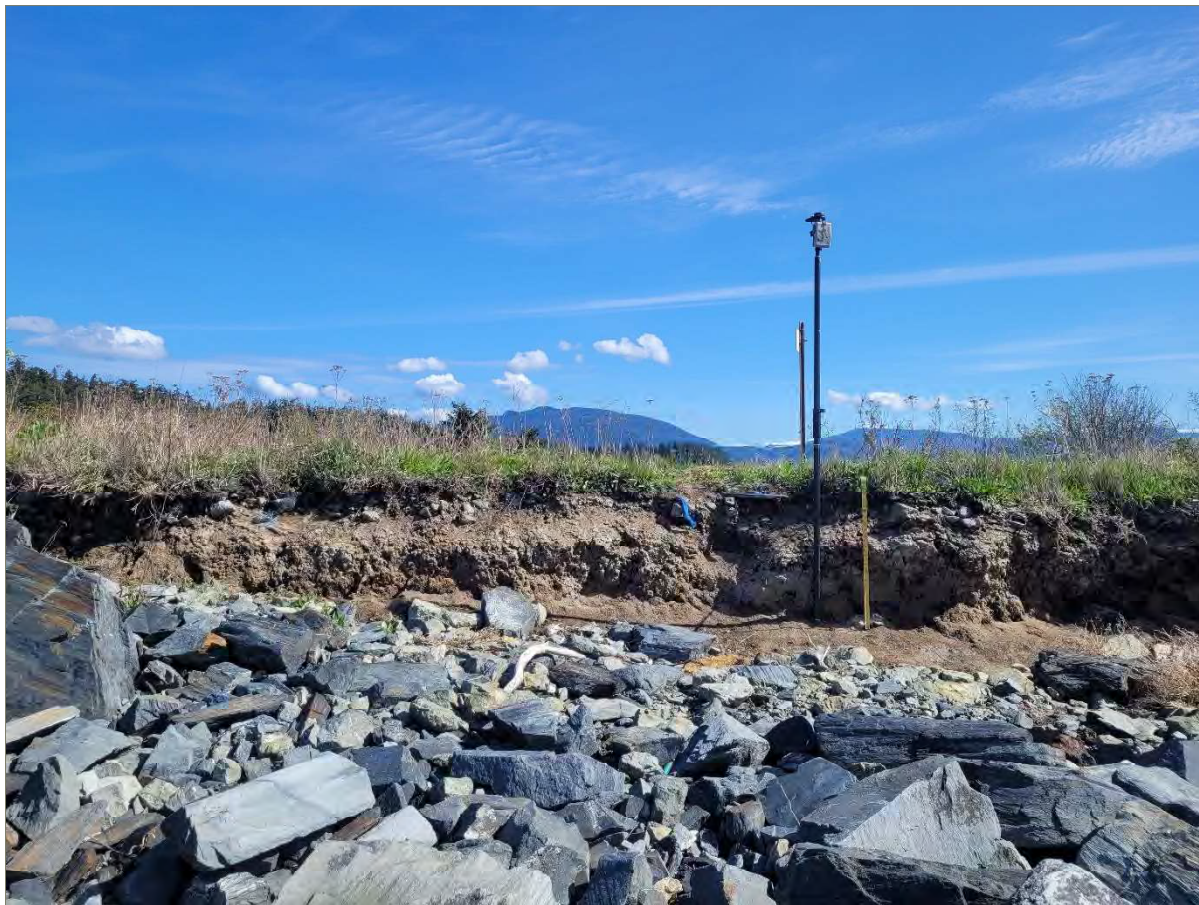
**Exhibit 3-8: Dike Erosion at GPS Point L**

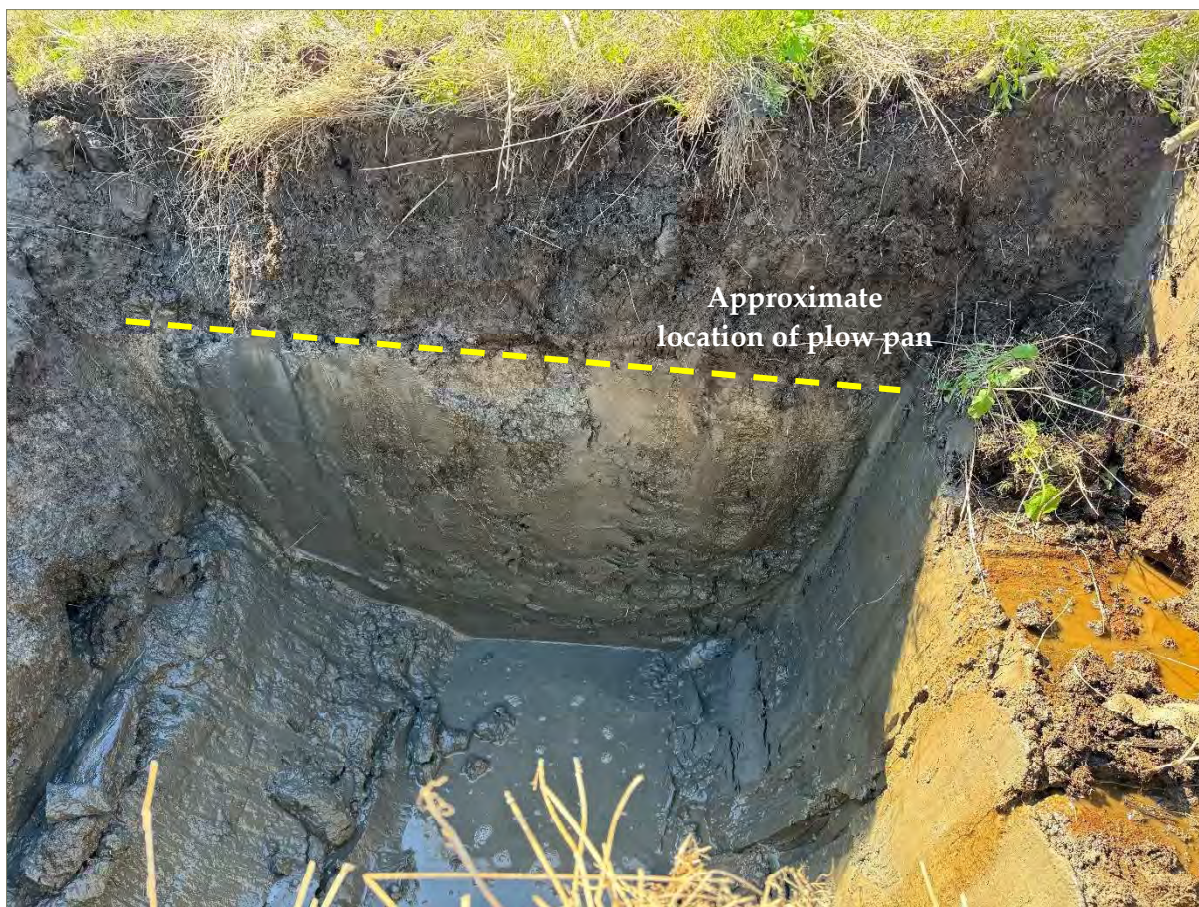
**Exhibit 5-1: Plow Pan Observed in TP-1**
