# Stratum Group Report Summary

October 16, 2024

**Re: Alluvial Fan Geology Assessment**  
West Big Lake  
Skagit County, WA

This geologic assessment was conducted to assess an alluvial fan and watershed on the west side of Big Lake in Skagit County, Washington. Numerous flood events have been reported on this alluvial fan. The most recent flood took place in November 2021. Flood events on the alluvial fan have been reported in 1991, 1995, 2003, 2015, 2016, and possibly in 2018. This geology assessment was conducted to provide an overview of the geology of the alluvial fan and watershed conditions relative to the alluvial fan to evaluate the potential hazards on the alluvial fan area and provide some conclusions and possible options for the alluvial fan area.

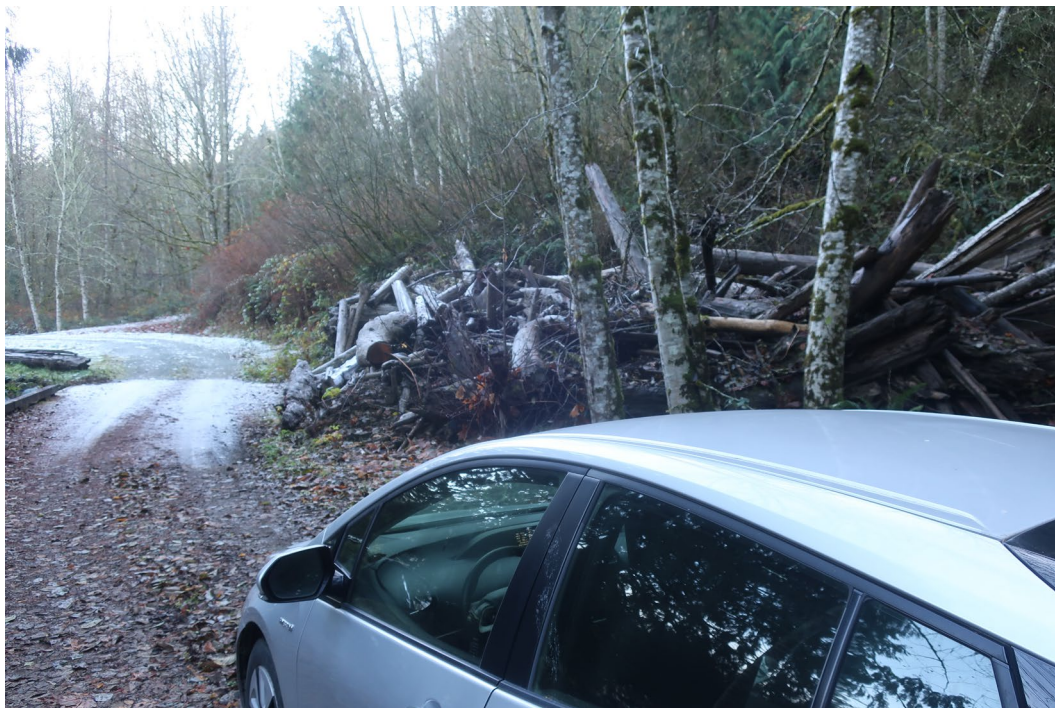
**Figure 2.** Large wood debris jammed at bridge West Lakeview Lane at the apex of the alluvial fan.

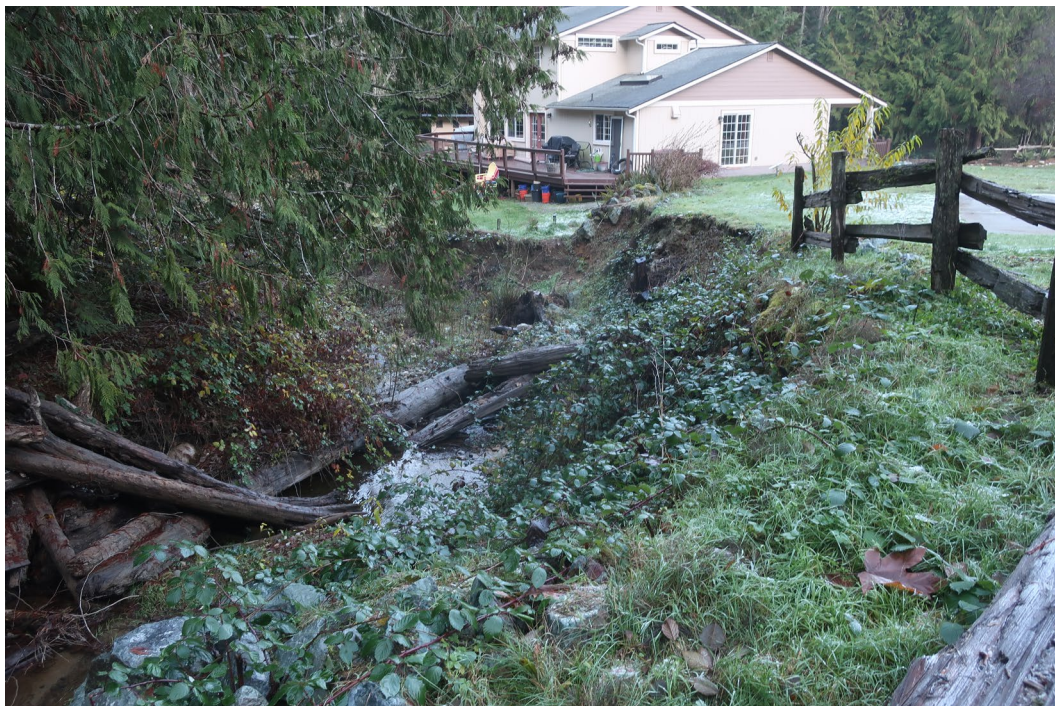
**Figure 3.** Deep incised stream reach on upper fan just below West Lakeview Lane bridge.

As described in the previous overview of alluvial fan hazards, portions of the alluvial fan may be at risk from erosion. Just below the bridge at West Lakeview Lane significant bank erosion took place as the stream takes a sharp bend and is relatively high gradient on the upper fan.

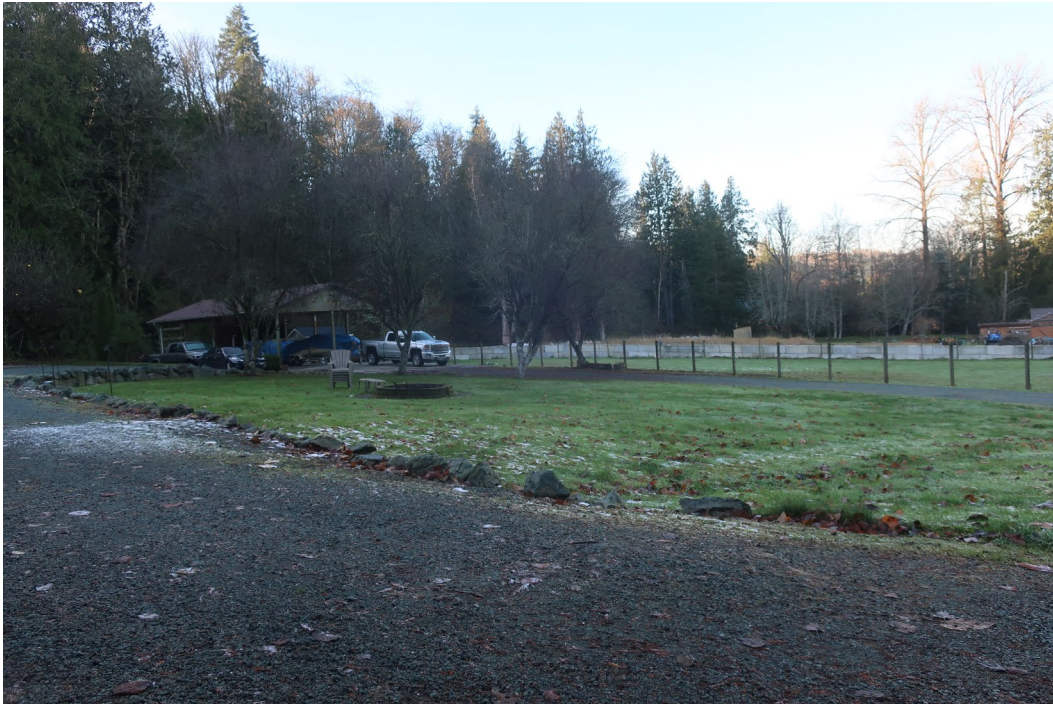
Figure 4. Overflow swale east of main stream which is located behind buildings.

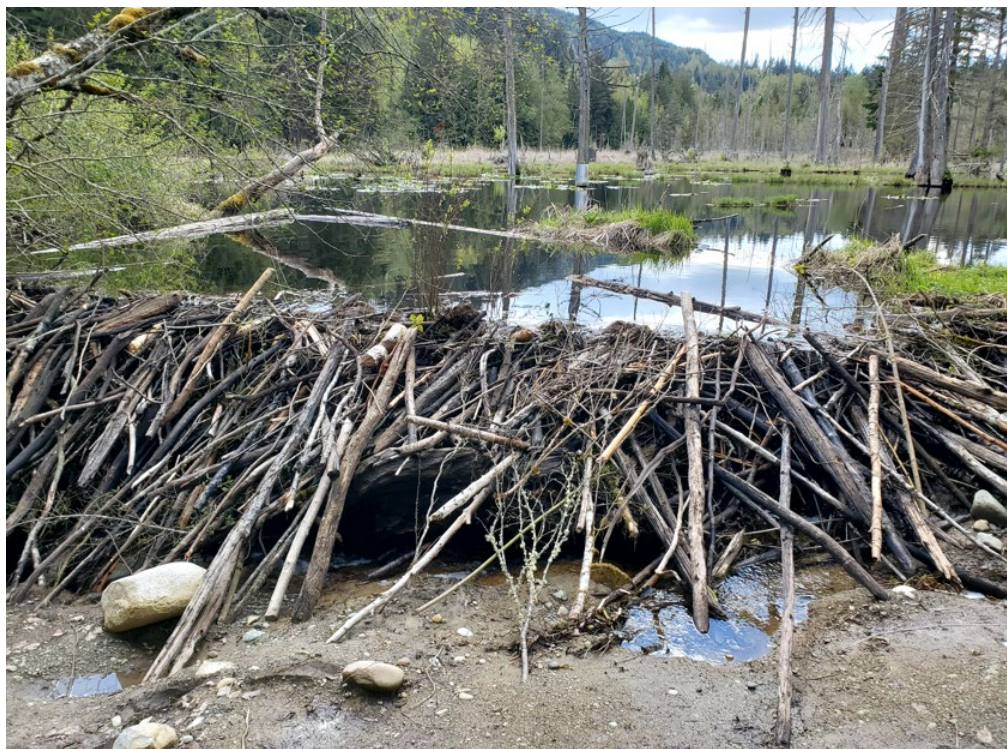
A portion of the beaver dam failed in 2021. Photographs of the dam break area showed scoured soil down to the dense glacial till (Figure 8). The pictures showed that the dam was rebuilt shortly after the failure. At the time of my site visit in November 2023 the scoured area immediately below the dam had become brush covered and vegetation was beginning to become established on portions of the newer dam (Figure 9).

Figure 8. Dam rebuilt at scoured glacial till where dam failed previously.

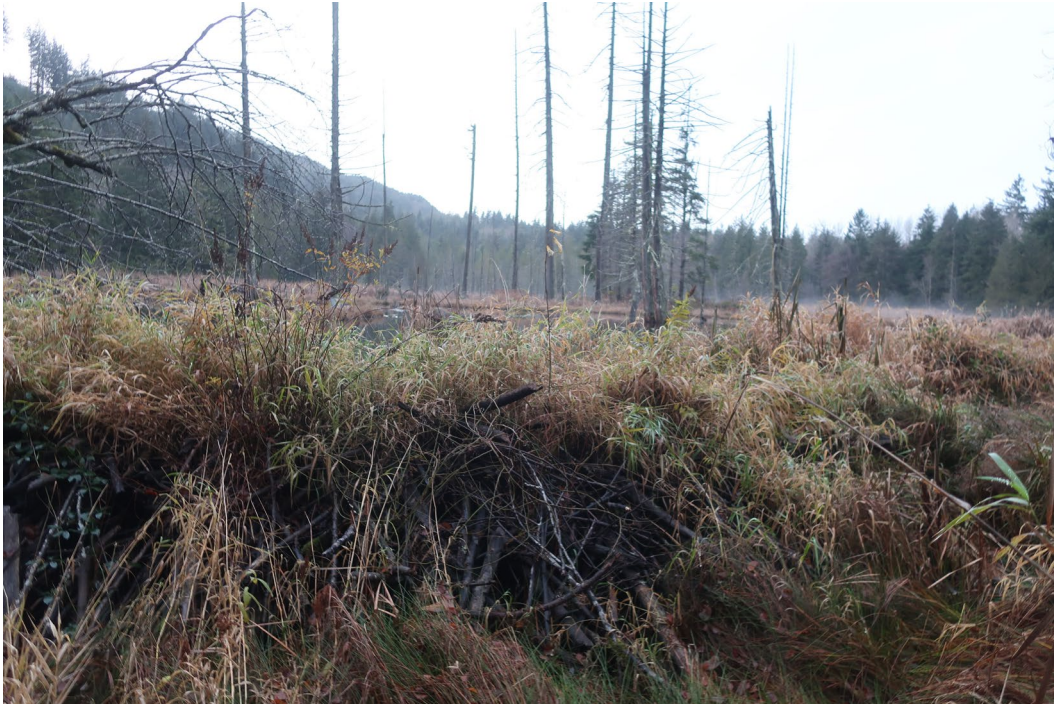
Figure 9. Vegetation established at newer dam area.

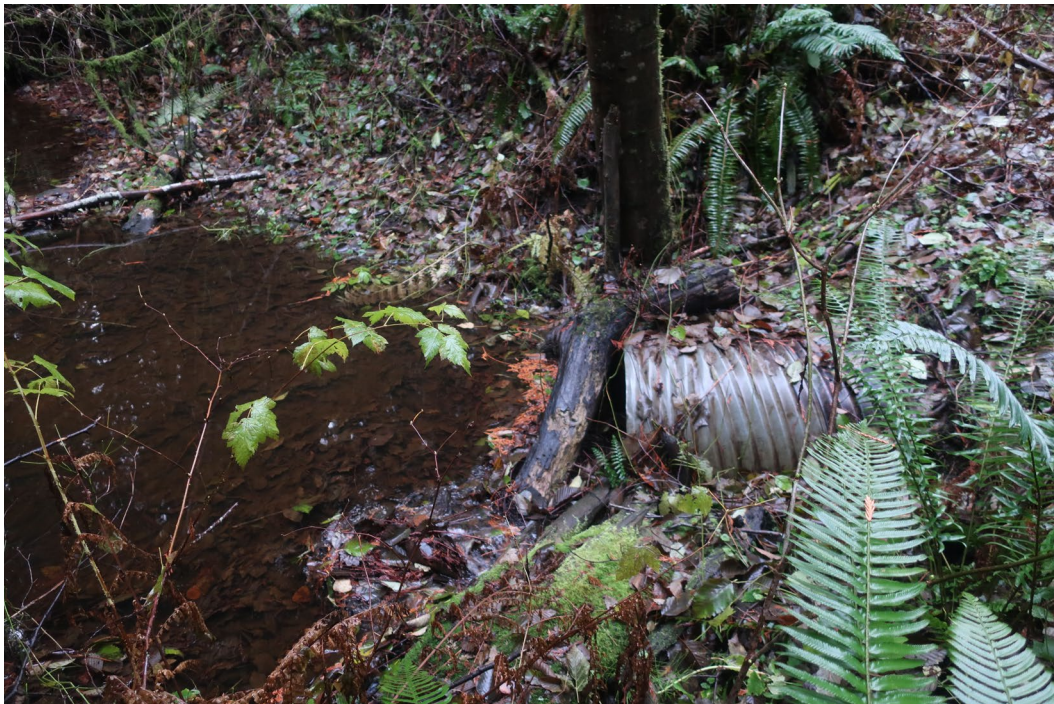
Downstream of the beaver dam there is an old logging road crossing the creek with a steel culvert (Figures 10 and 11). The crossing and culvert did not appear to be damaged. Water may have spilled over the top of the road; however, given that two years had passed since the flood event, the premise that water may have passed over the road is not certain.

Figure 10. Culvert inlet at old logging road

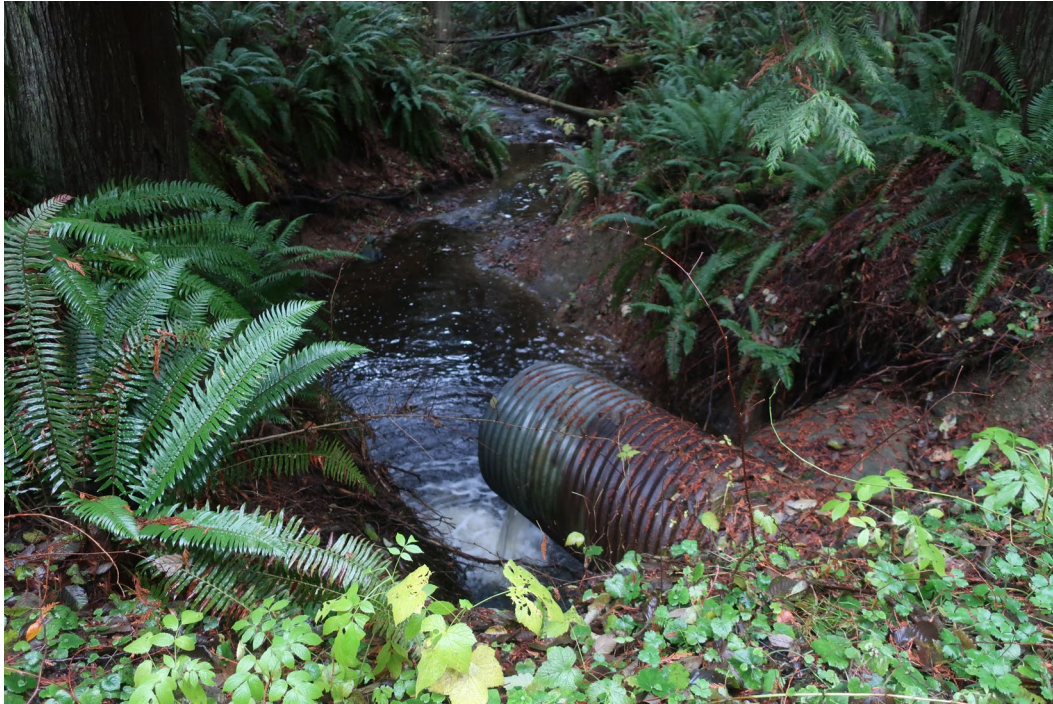
Figure 11. Culvert outlet at old logging road

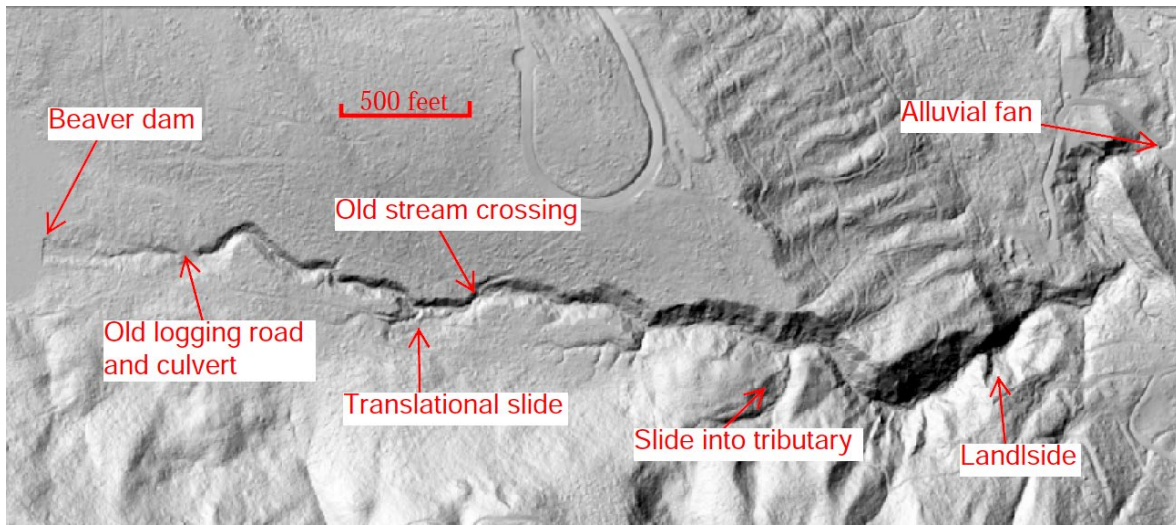
The steep narrow canyon is shown on a lidar bare earth image on Figure 12 with some ground truthed features marked up on the figure. Shallow landslide scars, slope ravel, tree toppling and scouring are evident throughout the canyon (Figures 13-15). As noted in the geology section, there is a deep-seated translational slide area where a large area exhibits slow periodic movement towards the canyon as evidenced by broken ground and recent cracking on the ground surface.

Figure 12. Lidar bare earth imagery of narrow steep canyon with significant features marked.

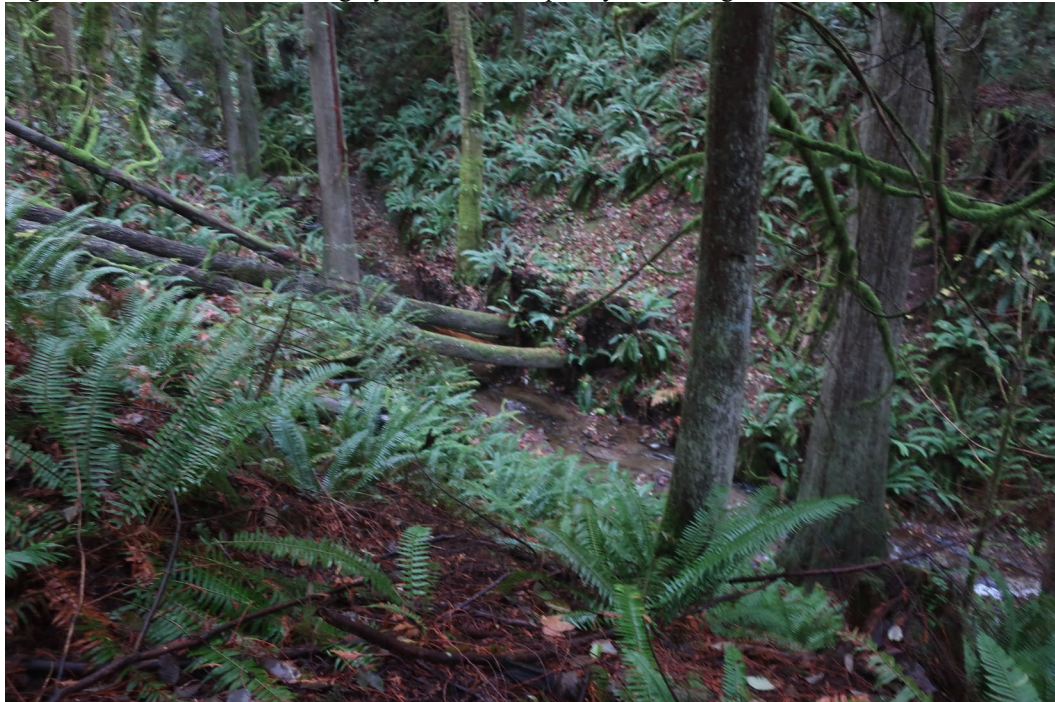
Figure 13. Toppled trees due to bank erosion in upper canyon.

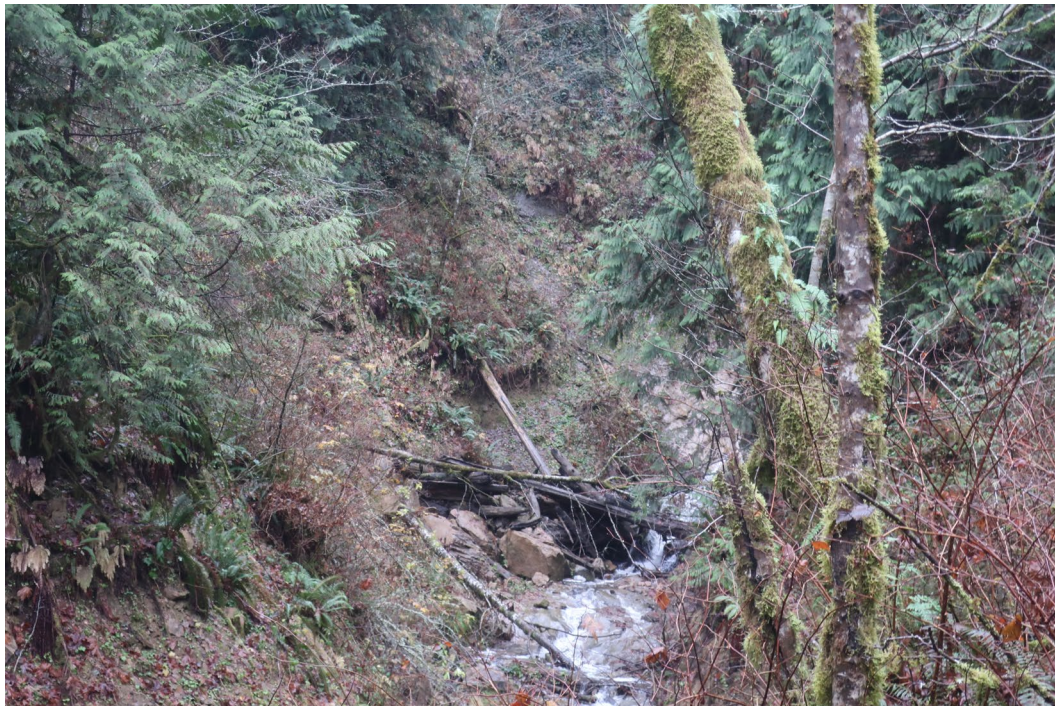
Figure 14. Shallow bedrock slide in steep narrow bedrock canyon

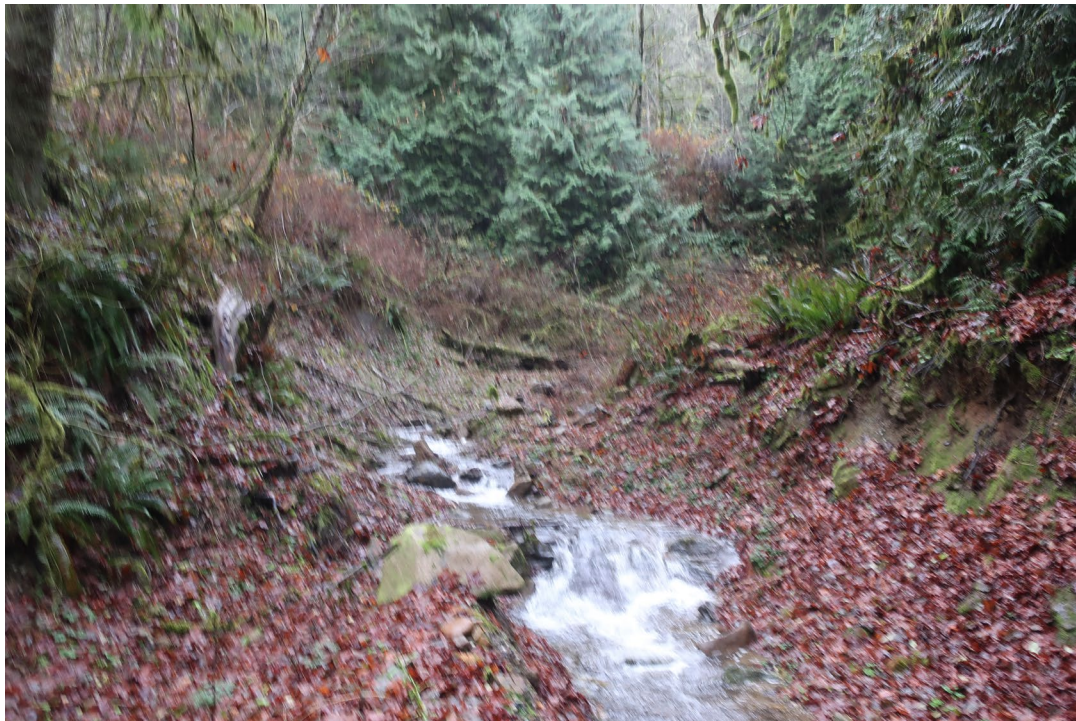
Figure 15. Broad area of scoured canyon on lower canyon

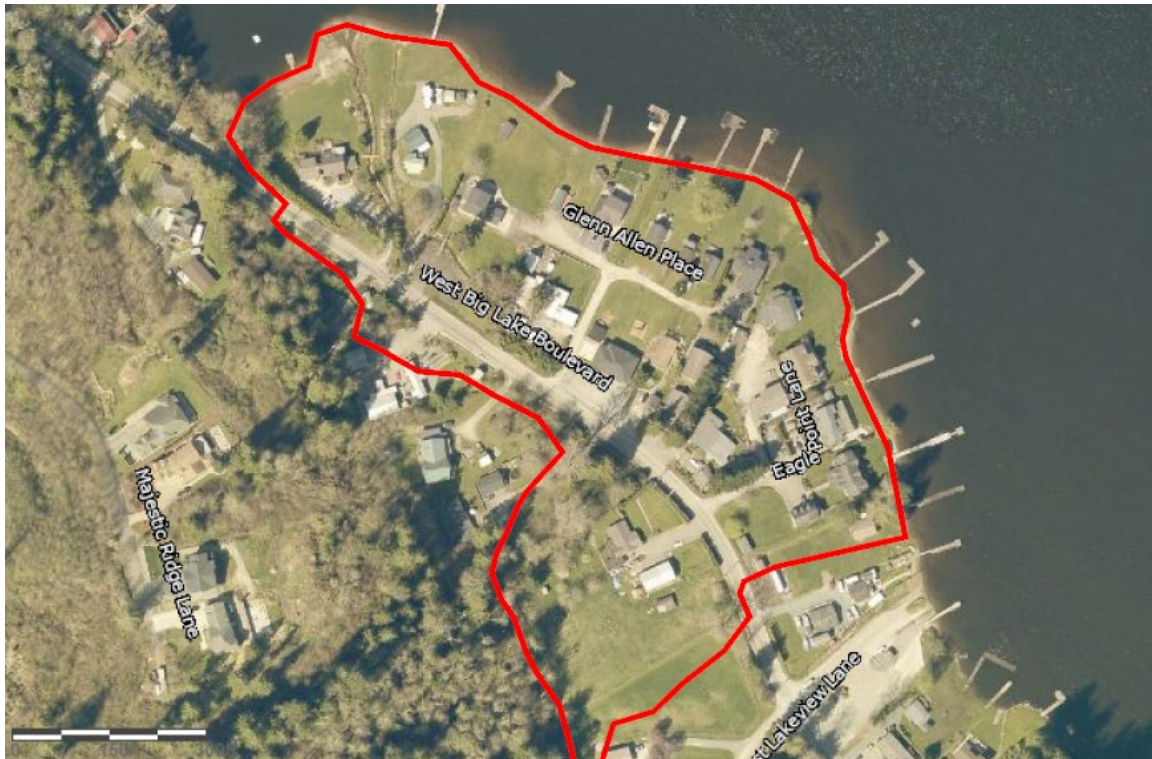
The 2021 flood impacted most of the alluvial fan (Figure 18). The stream avulsion took place at the back, west end of 18462 West Lakeview Lane (Figure 19). The escaped water flowed across

Figure 18. Estimated extent of flooded area from review of drone footage.

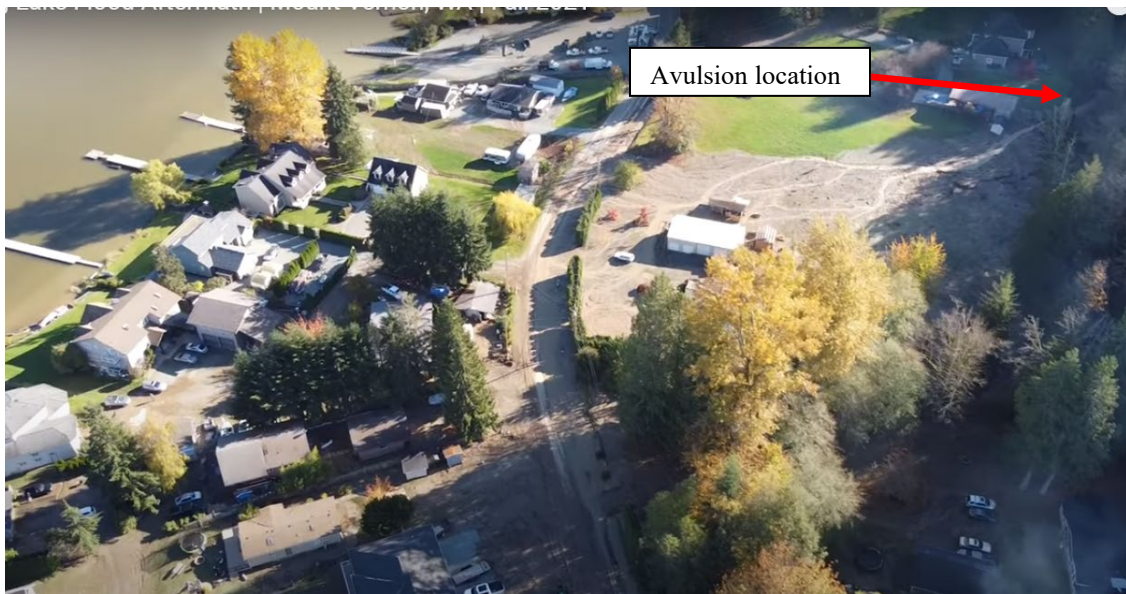
Figure 19. View of flooded area showing the avulsion location and area where flood water spread across the alluvial fan.

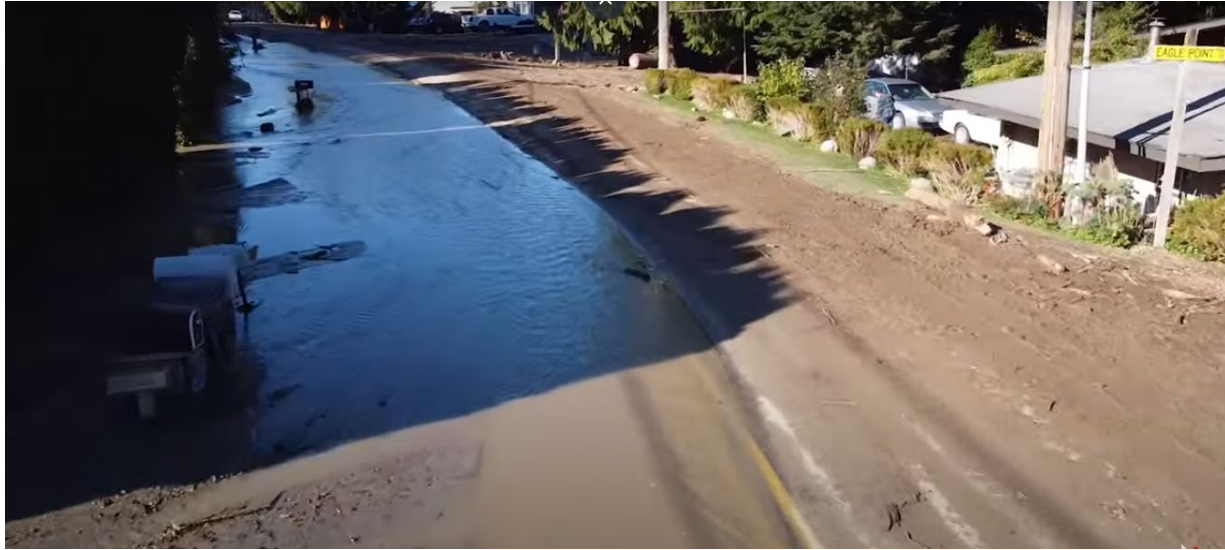
Figure 20. View of water flowing in ditch and on road. Note mud from higher water showing areas where water flowed across the road to the properties on the east.

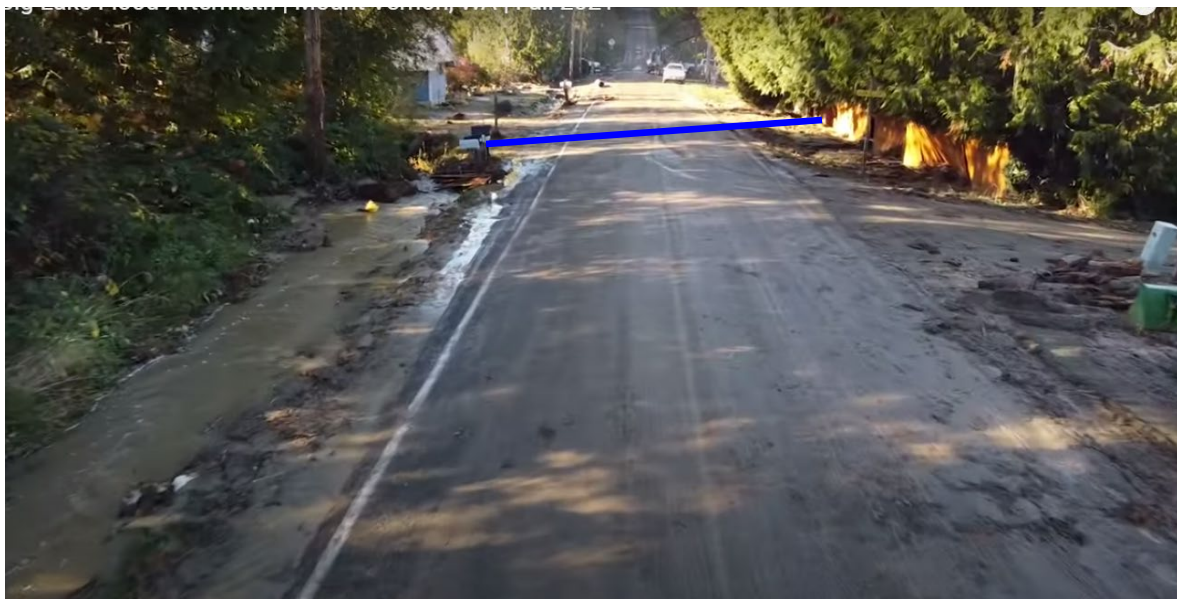
Note that flooding continued on parts of the fan long after the initial flooding took place due to the fact that the main stream channel had been filled with sediment as had the ditch areas and the stream was flowing across multiple routes across the alluvial fan. However, at the time of the drone video all the water from the stream was passing through the culvert under West Big Lake Boulevard (Figure 21). However, a careful review of the drone imagery showed that water was still flooding from the stream channel below the culvert due to sediment accumulation in the channel.

Figure 21. View of water flowing in ditch to stream culvert indicated as blue line across road.
