Padilla & Samish Bays Coastal Protection and Conservation Project

Phase 1 Public Meeting

October 10, 2024

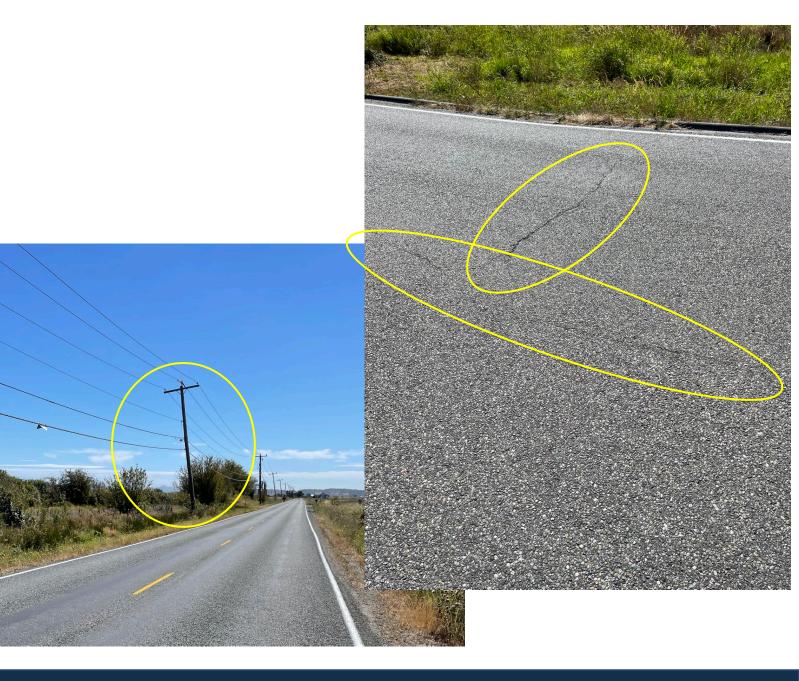
Road & Utility Conditions

- Samish Island Road
 - Longitudinal and transverse cracking on north end
 - Slight rutting the full length
- Leaning utility poles (power and communication)
- Water main parallels and crosses under road – condition unknown

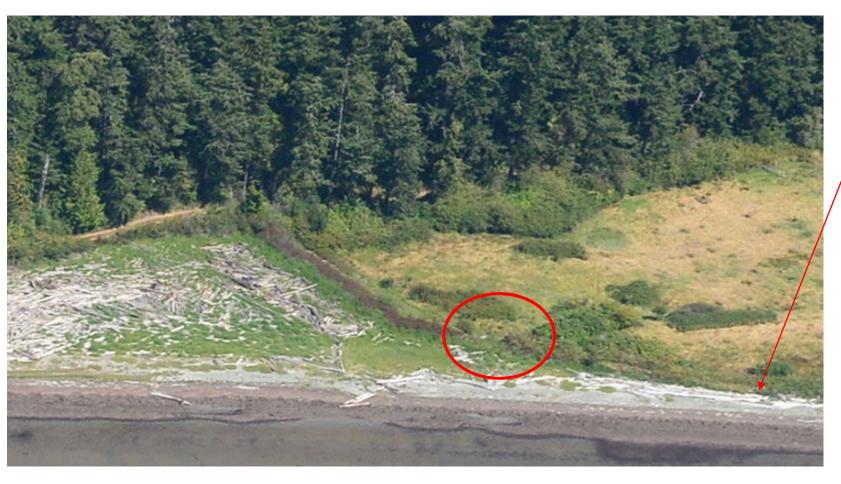
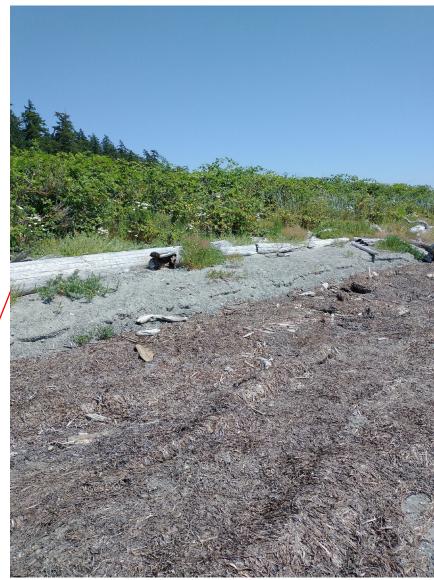
Padilla Bay Dike North

No armor along portions of the dikeEarthen dike is lower than other areasKnown overtopping during extreme water levels

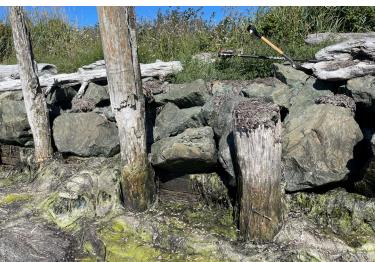
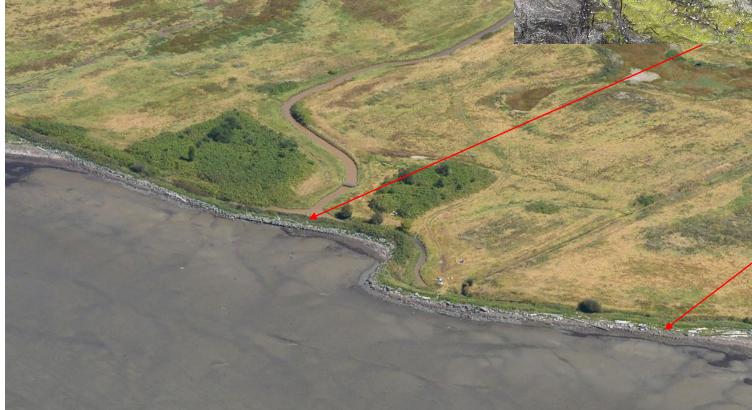
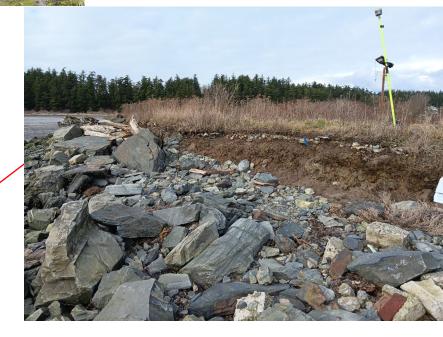
Padilla Bay Dike South

- Degrading Rock and Pilings
- Dike erosion/slumping
- Pockets of shoreline erosion

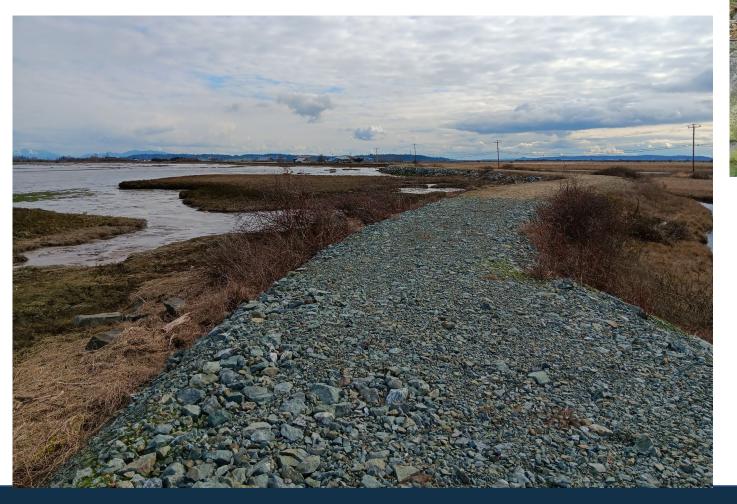
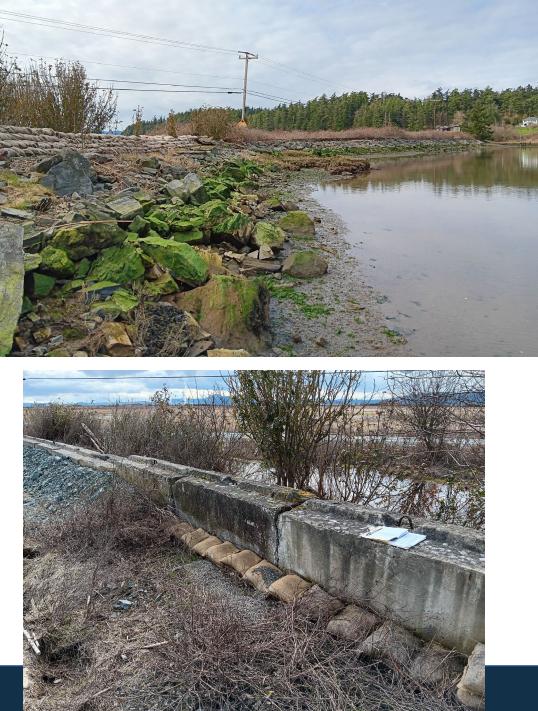
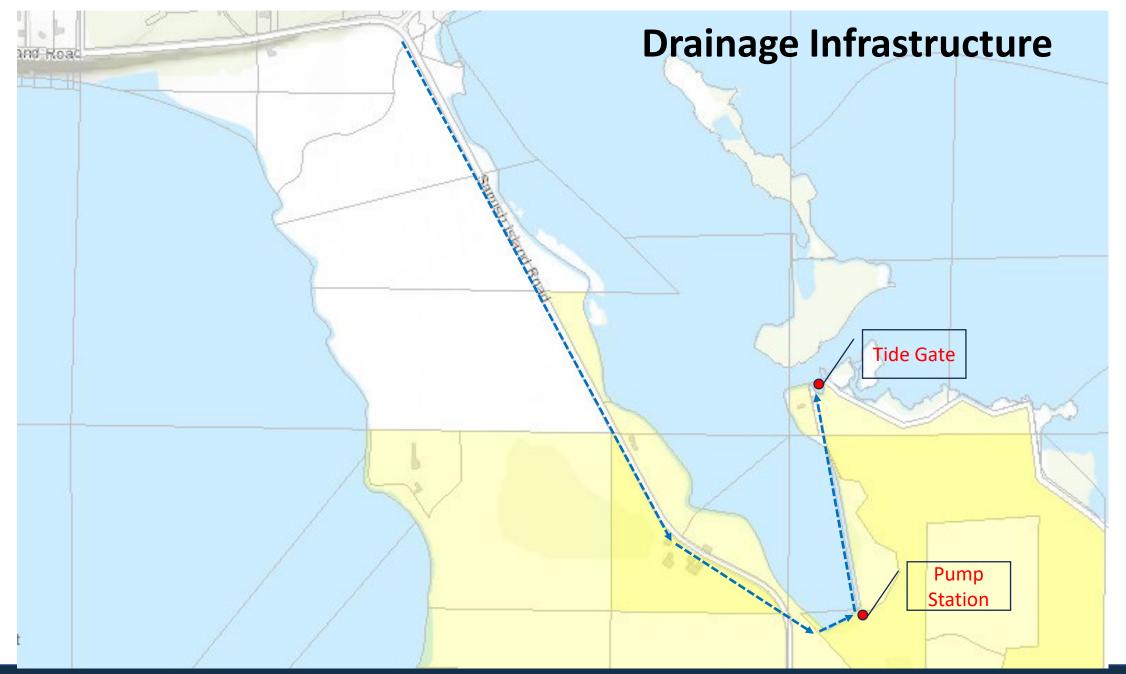
Alice Bay Dike

- Varies in age and construction
- Various repairs with low grade materials
- 2022 Rebuilt Dike to DD5 standards

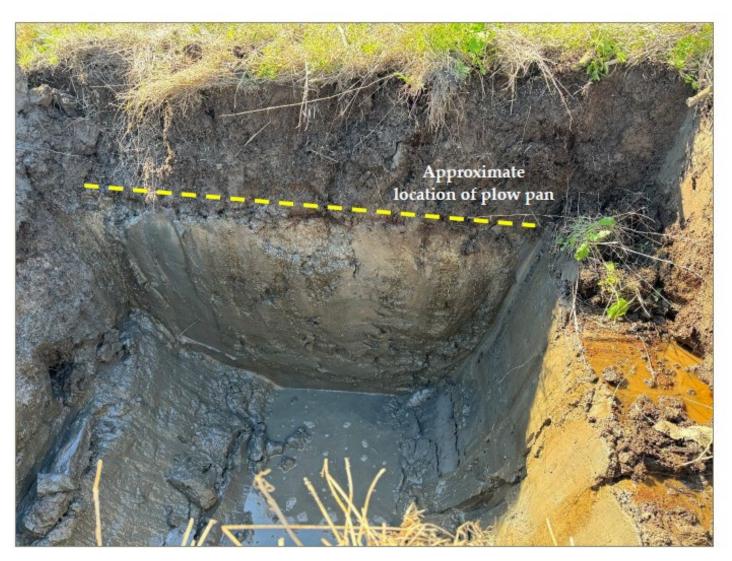
Exhibit 5-1: Plow Pan Observed in TP-1

- Historic Marsh sediments
- Some beach deposits
- Plow pan from agriculture
 - Dense/ not porous
 - Restricts vegetation growth
