Samish Island Conservation Area Restoration

# Feasibility Study and Conceptual Restoration Ideas Report

January 2025

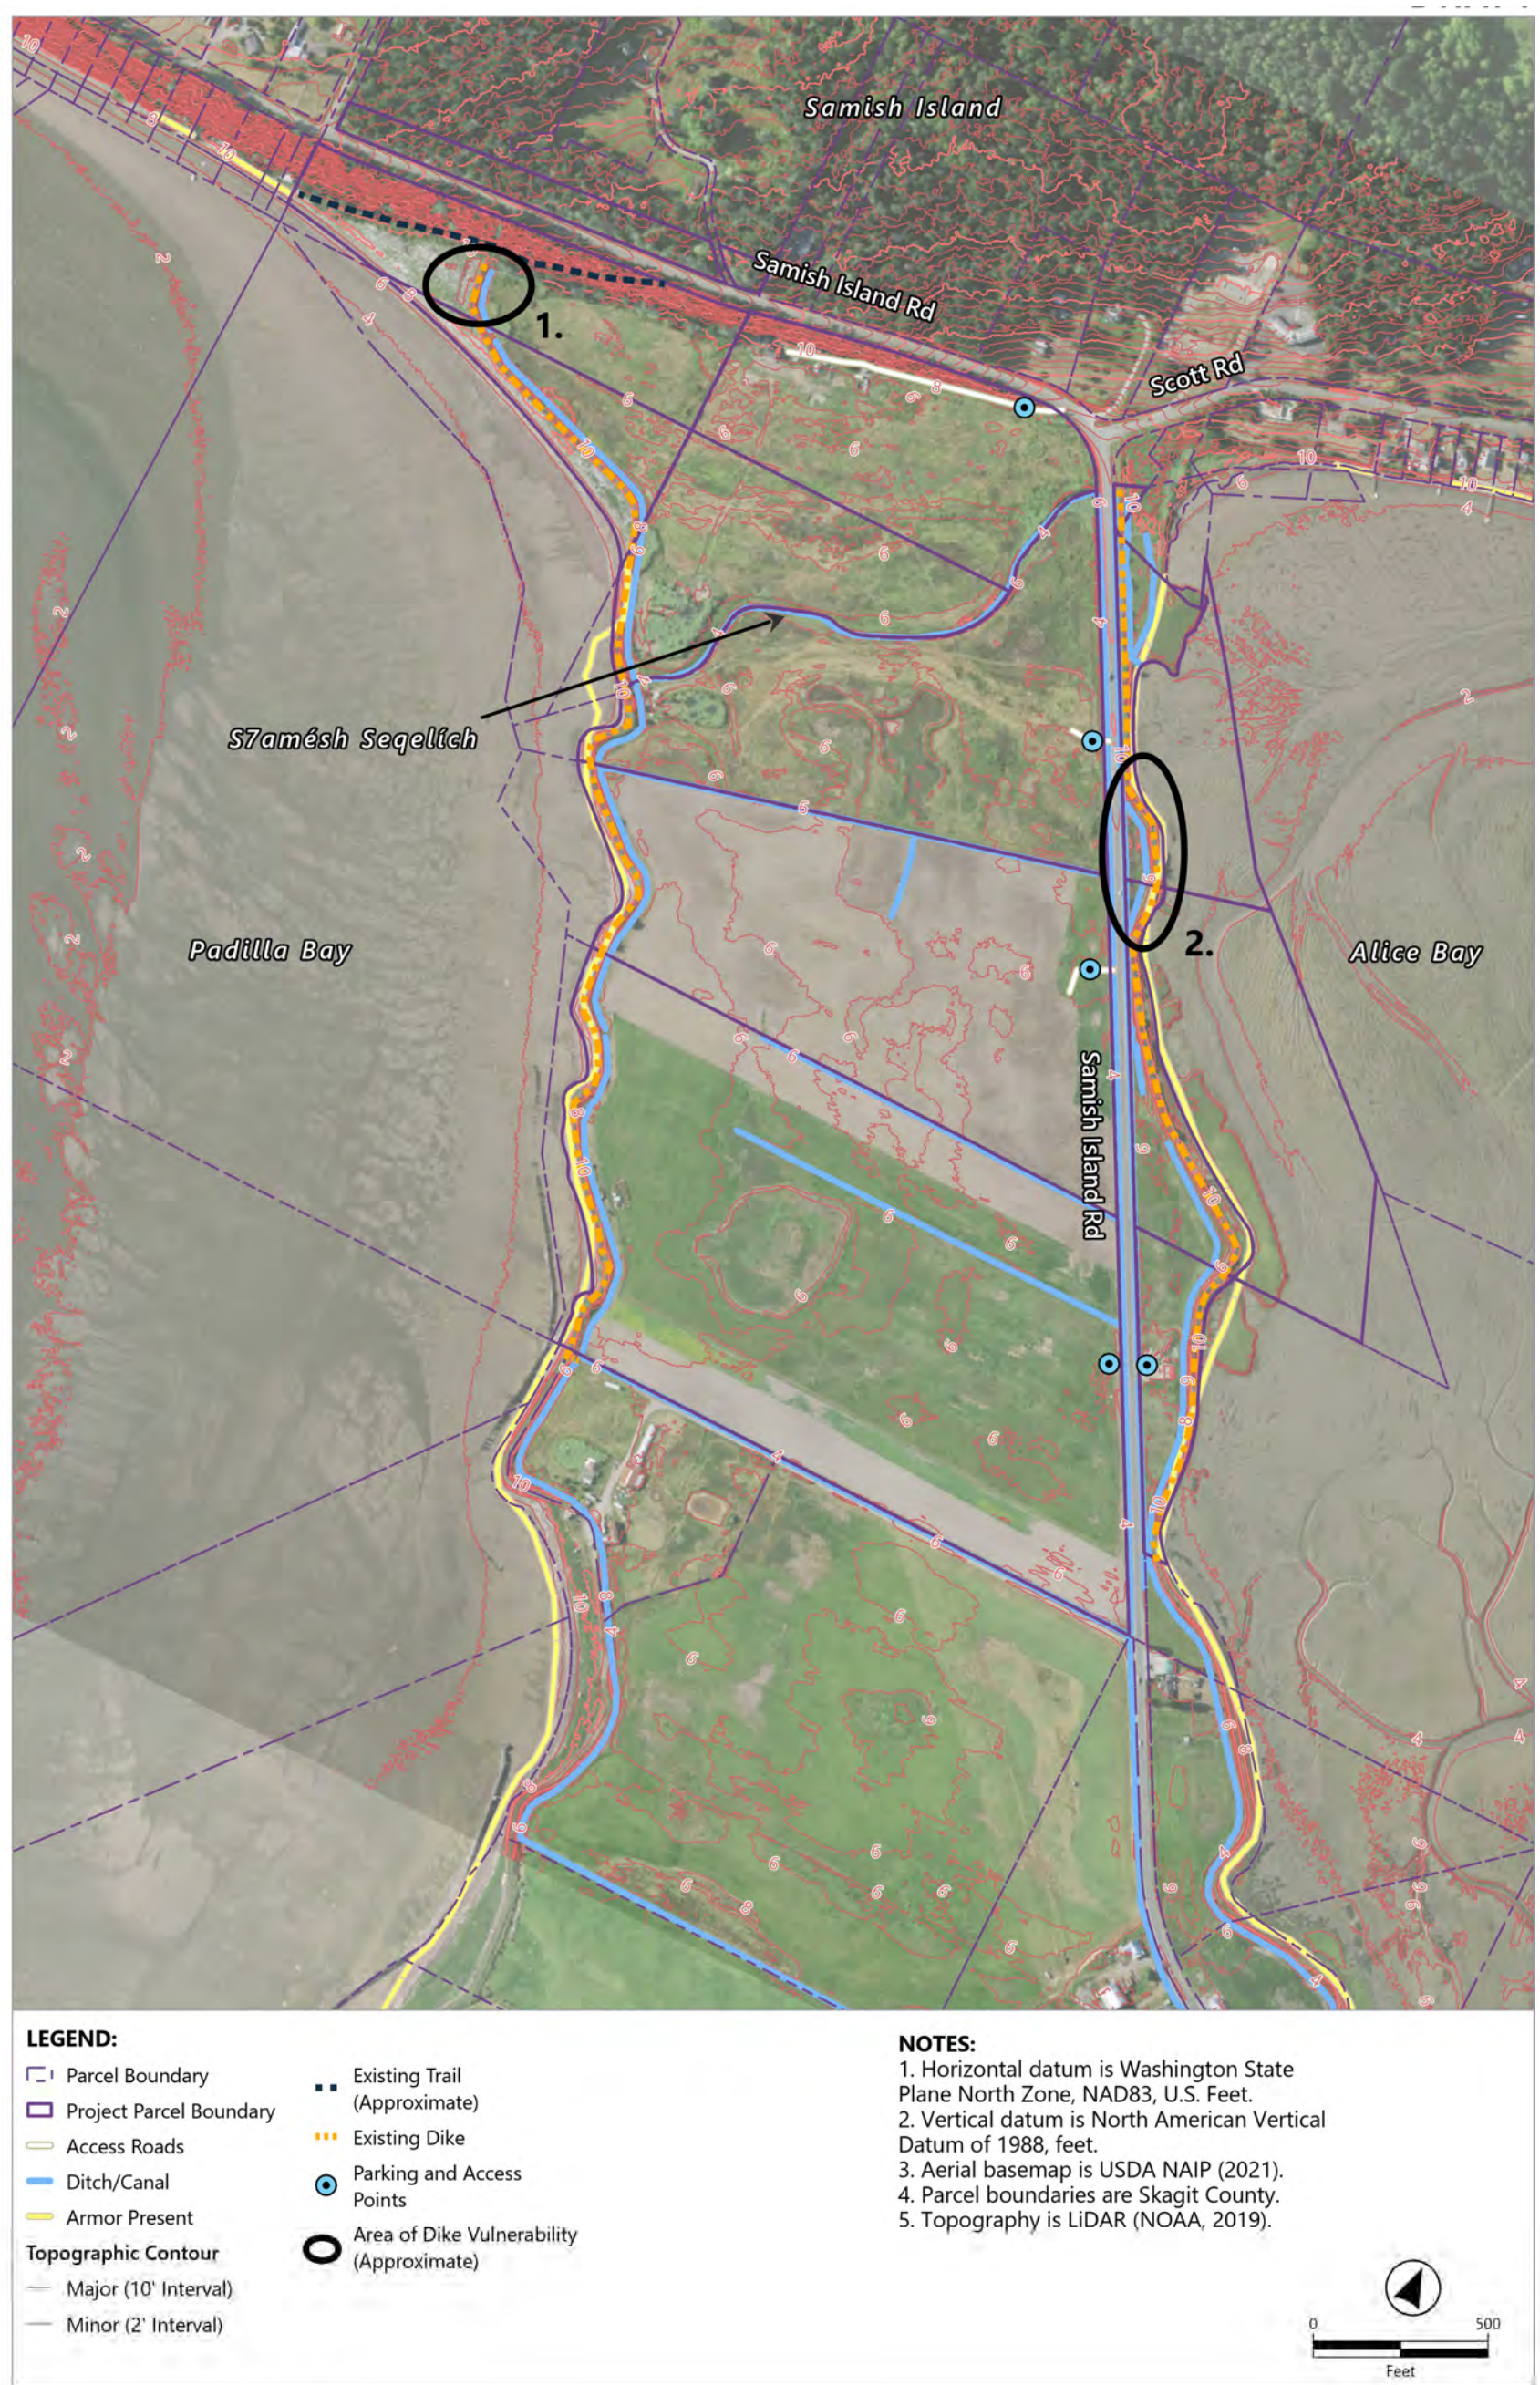
Figure 13. Restoration Concept 1 for no restoration action.

- No substantive changes to the Padilla Bay and Alice Bay dikes are identified.
  - Coastal overtopping of the Padilla Bay dikes will continue to occur at water levels above 8.6 feet NAVD88, which is between MHHW and HAT (similar to a King Tide) shown as Area 1 on Figure 13.

- Coastal overtopping of the Alice Bay dikes will continue to occur at water levels above 9.7 feet NAVD88, which is equal to HAT (similar to King Tide) shown as Area 2 on Figure 13.

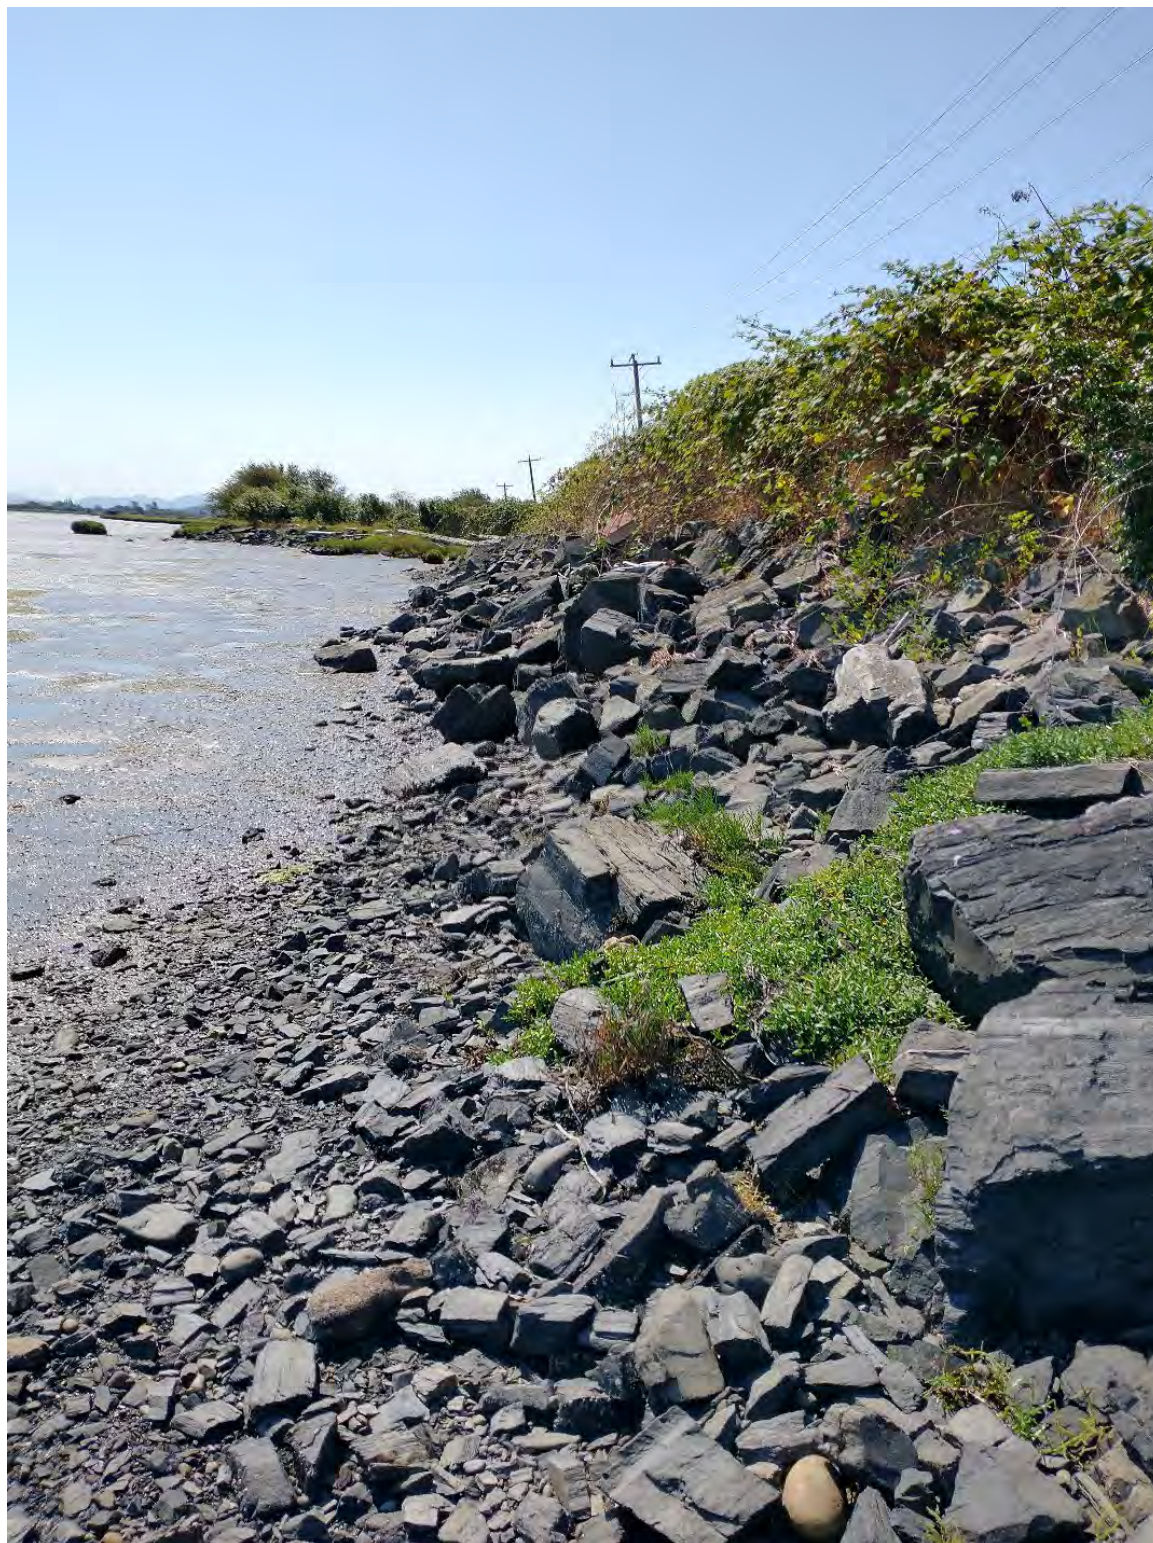
**Figure A-5. Rock armoring along the eastern shoreline (July 2022 photo). View looking south.**

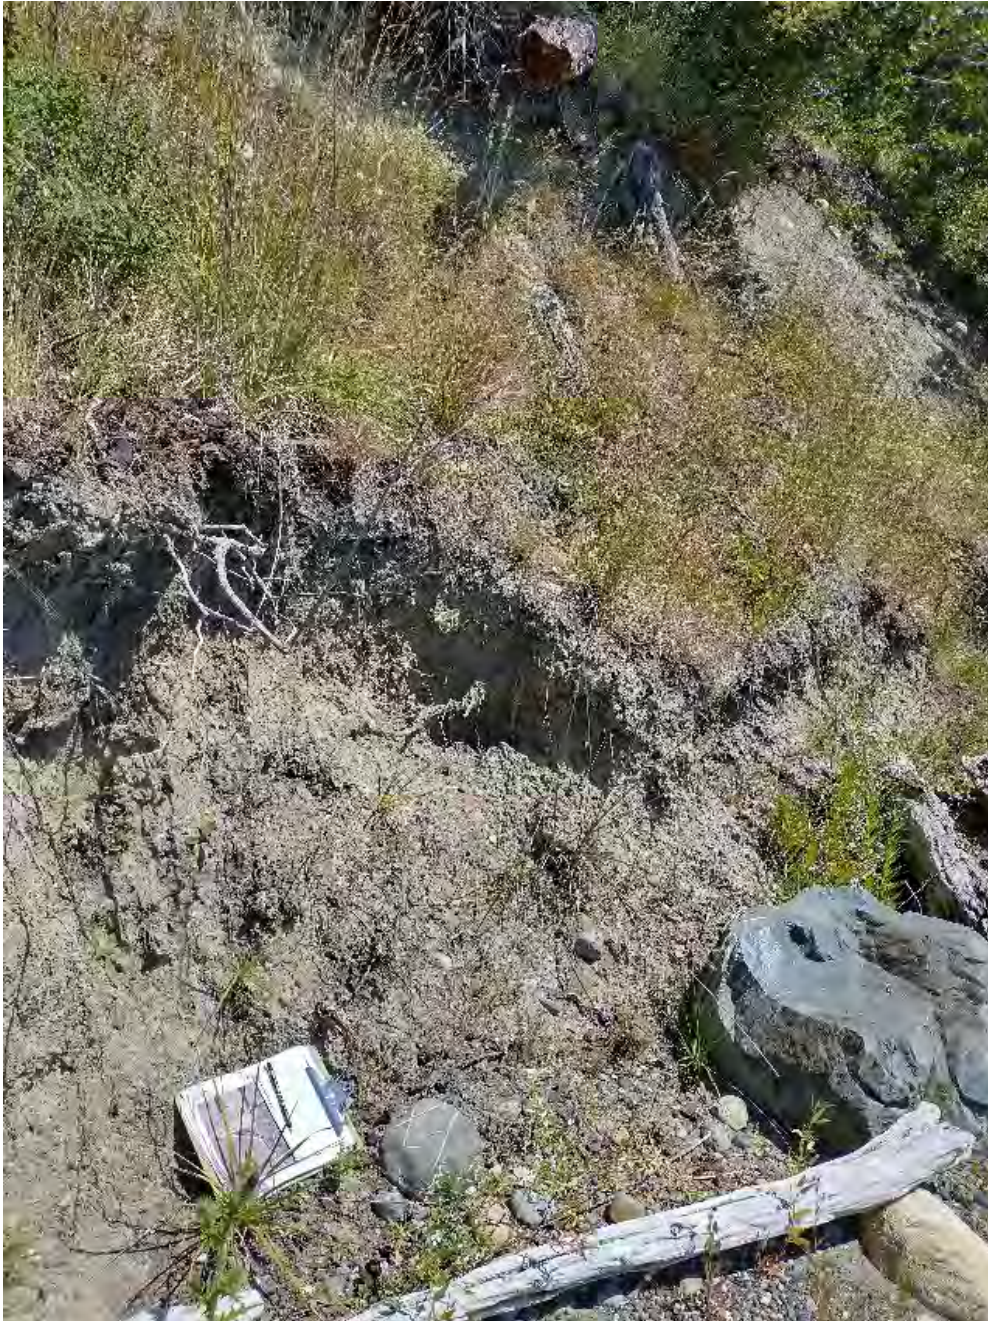
**Figure A-7. Exposed feeder bluff sediments on Samish Island, to the west of the project site (July 2022 photo).**

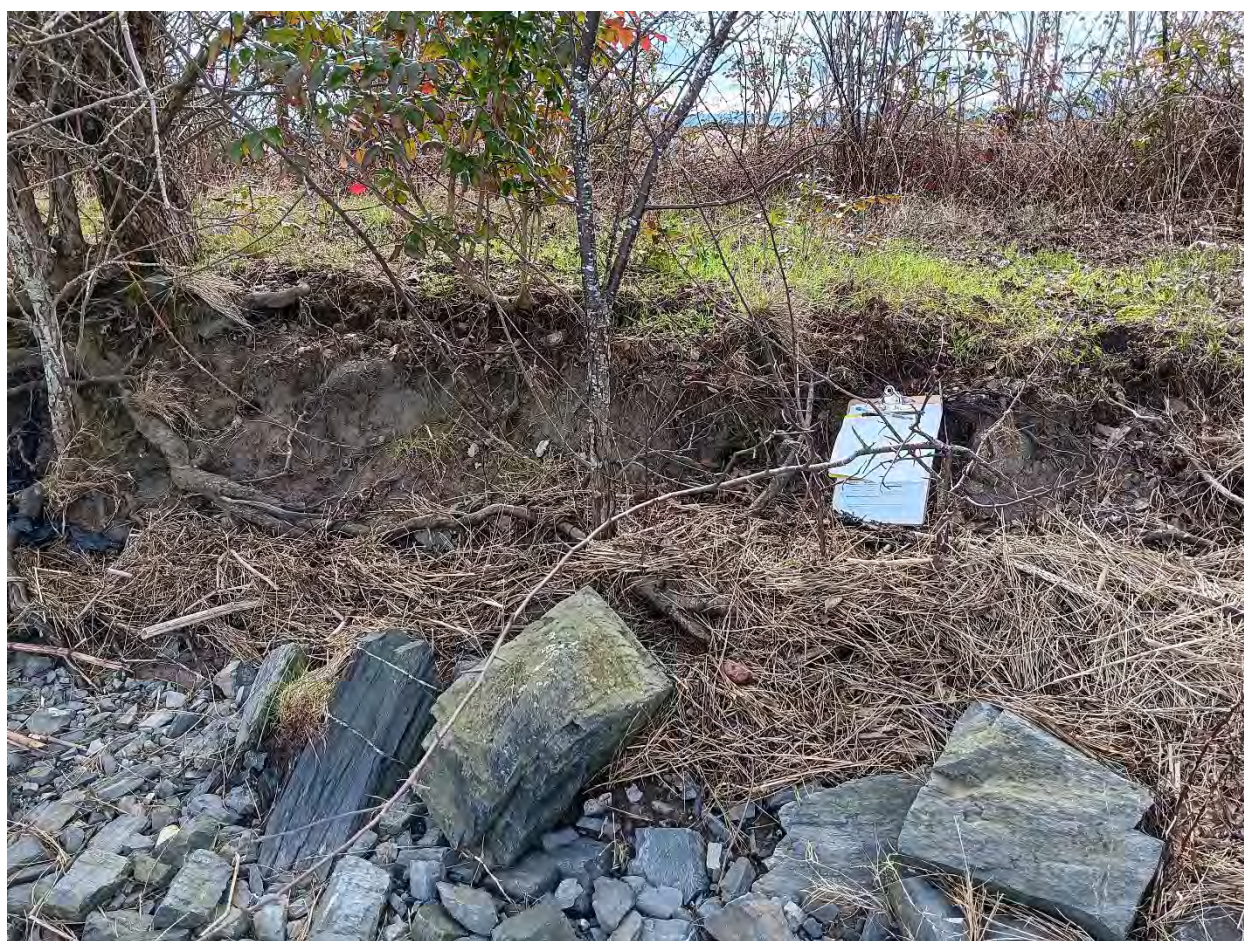
- The eastern shoreline along Alice Bay is armored with randomly placed (not stacked) armor stone. Erosion of the bank was noted along a 10- to 15-foot length of the bank with a scarp (vertical bank indicating erosion) 1 to 2 feet in height.
- At the approximate center of the eastern shoreline there is a section of armoring consisting of two 100- to 150-foot lengths of Eco-blocks and quarry spalls that were placed as emergency repairs and remain in place.
- The south end of the shoreline consists of the recently repaired dike, which is 2 to 3 feet in height above the saltmarsh and armored with granite riprap rock on the waterward face. The top of the dike consists of crushed gravel. The dike is several feet above Samish Island Road.

**Figure A-14. Scarp along the eastern shoreline in Alice Bay (March 2024 photo).**

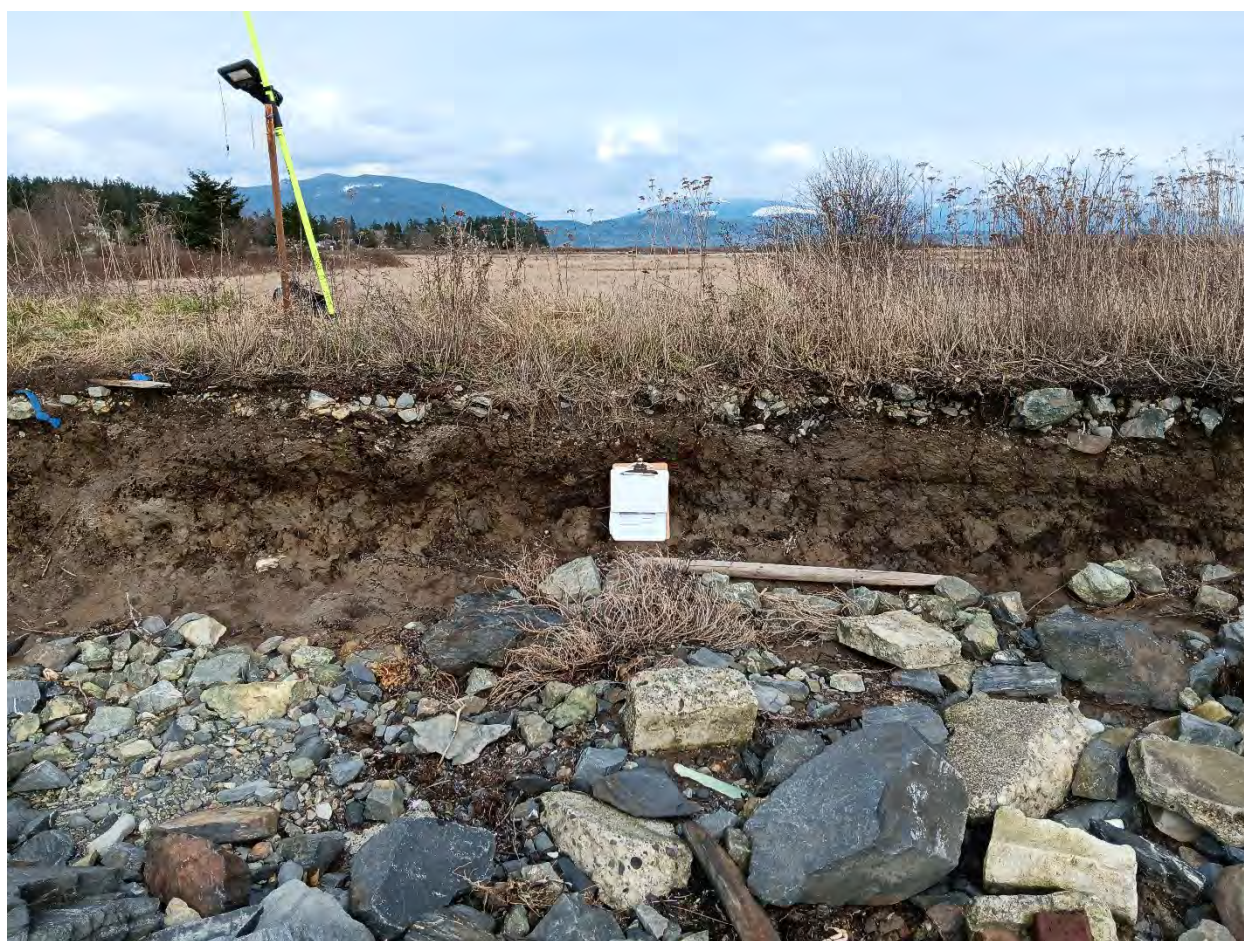
- The western shoreline along Padilla Bay is backed by an older dike built from compacted soils and not well-stacked riprap of poor-quality sedimentary rock. Several short lengths of the rock have slumped, leaving the soil bank exposed. Observations of scarps, 1.5 to 2.5 feet in height, were noted in several places in the soil bank.

**Figure A-17. Scarp along salt marsh on western shoreline (March 2024 photo).**

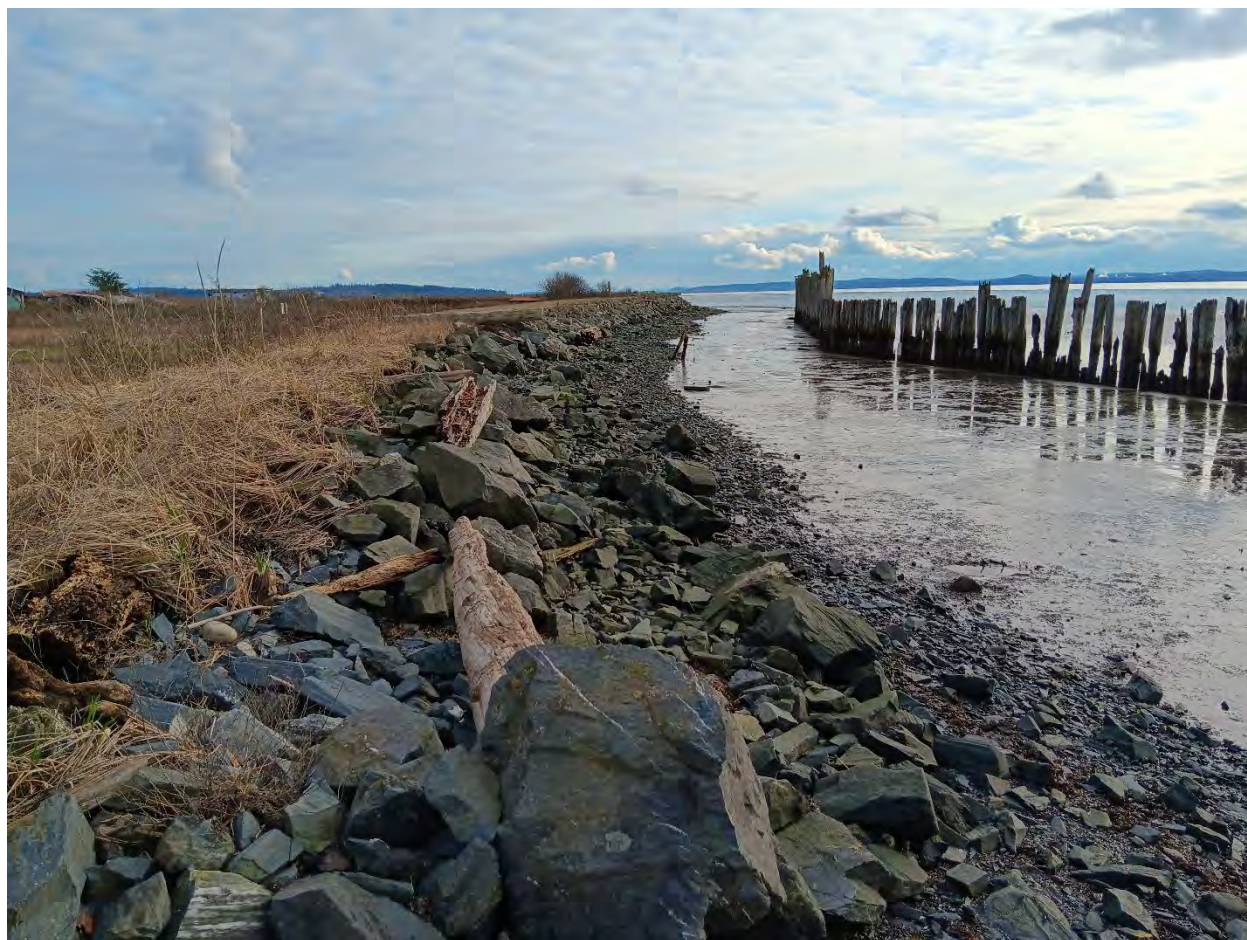
**Figure A-17. View to the south of the southwestern shoreline. Pile dike wall is to the right (March 2024 photo).**

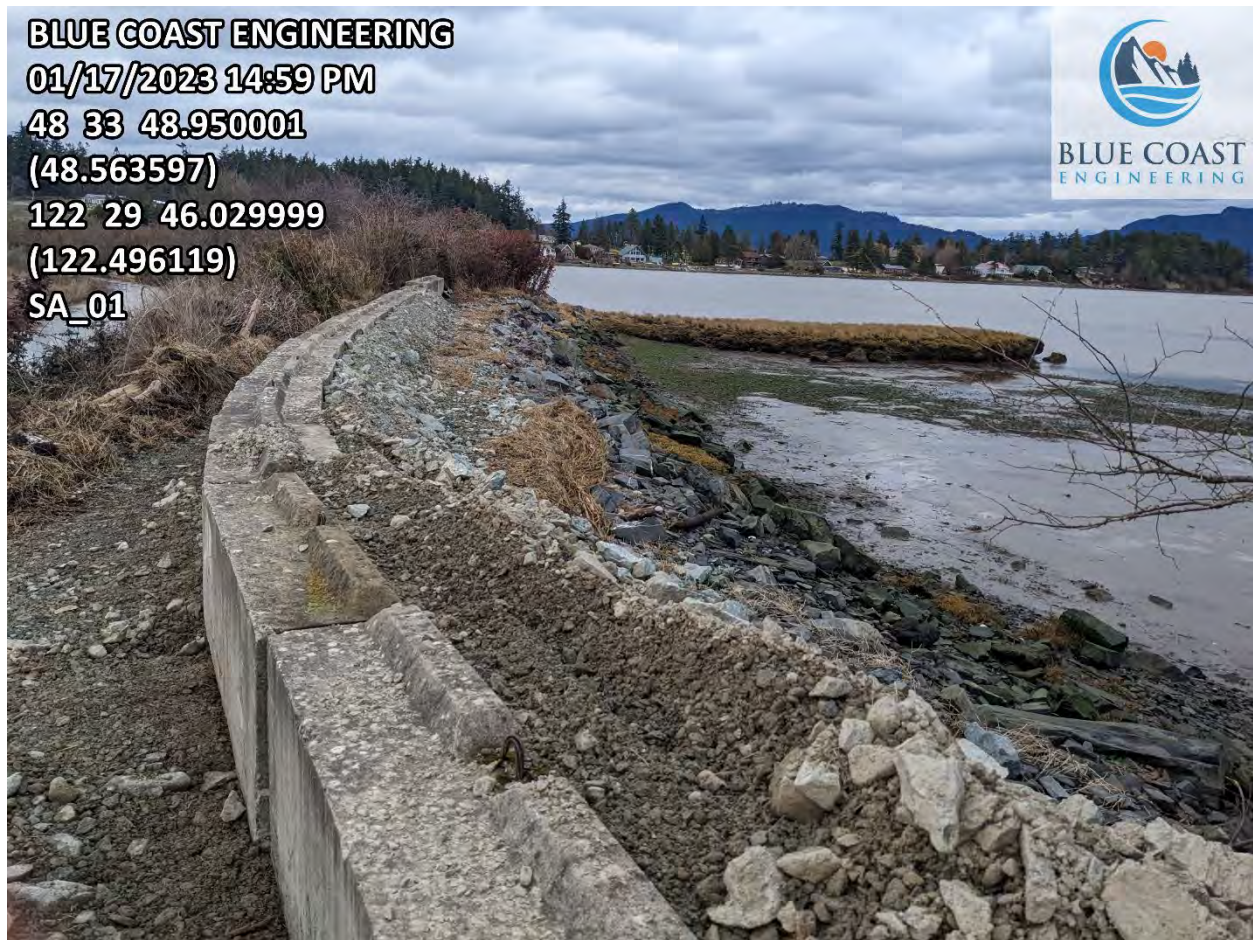
Figure B-2. SA\_01. Photo taken on January 17, 2023, after a large king tide event.

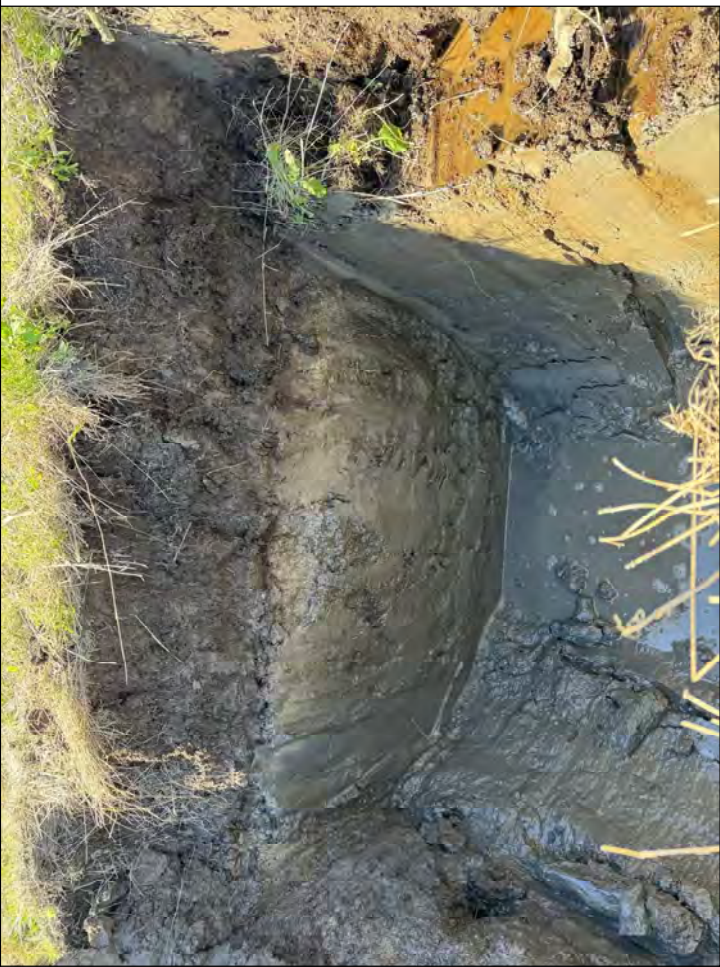
TP-1

Elev. (feet)		Depth (feet)		Material Description and Other Observations	Graphic	Samples	Test Results	Test Pit Diagram or Photograph North Side of Test Pit
5	1			Brown, <b>SILT WITH SAND</b> (ML); moist to wet (local seeps at bottom); fine sand; low plasticity; some organics (roots, grass, and woody debris), buried lumber at base; massive, crumbly structure. -Ring dike around pond.

4	2			-Lumber at 2.5 feet bgs. -Sharp contact at 2.5 feet bgs.				
3	3			Gray to olive-gray, <b>ELASTIC SILT</b> (MH); moist to wet (local seepage); trace fine sand; medium to high plasticity; little organics (roots and woody debris); locally crumbly structure with iron oxide staining.			WC=78% FC=98% LL/PI=97/65	
2	4			-Sharp contact at 4.0 feet bgs.				
1	5			Gray, <b>SILT WITH SAND</b> (ML); moist to wet (prominent seepage at several locations); fine sand; nonplastic; trace organics (roots and woody debris); massive.			WC=34% FC=14%

0	6			-Prominent groundwater seep out of a hole in the sidewall of the pit at approximately 5 feet bgs, the flow was approximately 1 to 2 gpm.  -Artesian boils at base of test pit, the flow was approximately 0.5 to 1 gpm.  BOTTOM OF HOLE AT 6 FEET

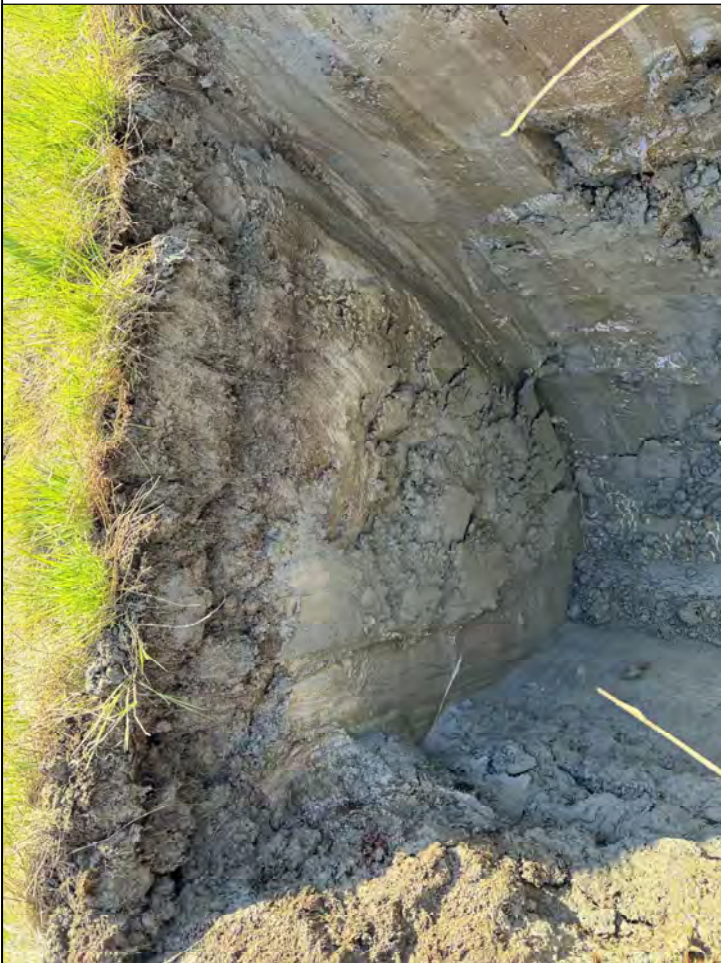
Elev. (feet)		Depth (feet)	Material Description and Other Observations	Graphic	Samples	Test Results	Test Pit Diagram or Photograph East Side of Test Pit
5			Brown, <b>SILT WITH SAND</b> (ML); moist to wet (seeping at bottom); fine sand; trace clay; abundant roots, crumbly structure.

4		1	-Sharp contact at 1.1 feet bgs.				
3			Olive-gray to gray, <b>ELASTIC SILT</b> (MH); moist to wet (locally seeping at cracks); trace fine sand; fining-upward; medium to high plasticity; some organics (roots and woody debris); massive, crumbly structure; trace iron oxide staining.

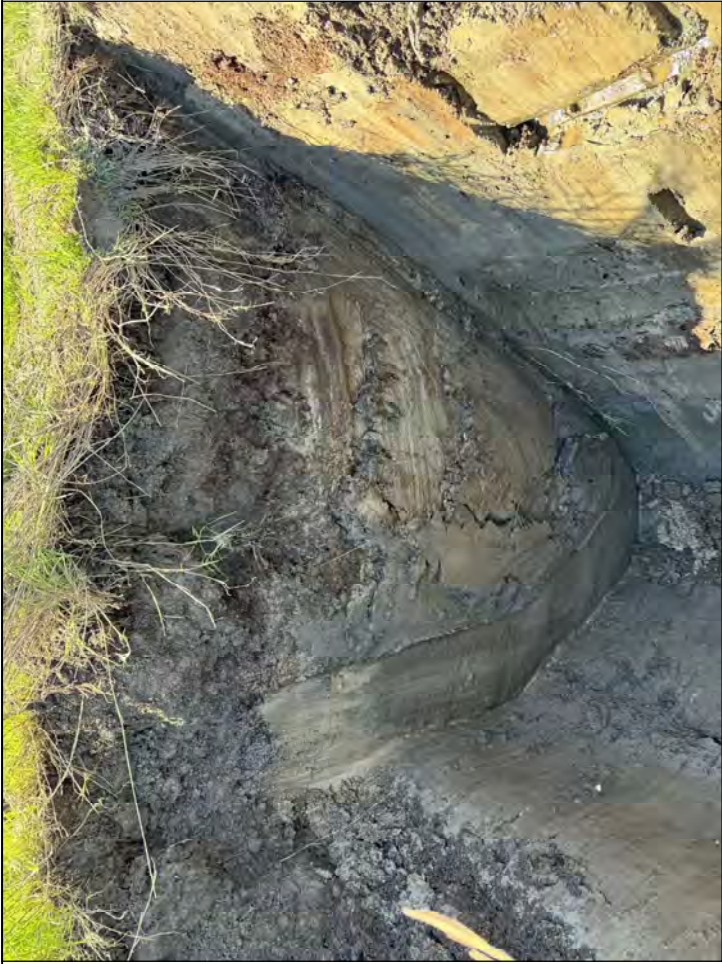
Elev. (feet)		Depth (feet)		Material Description and Other Observations	Graphic	Samples	Test Results	Test Pit Diagram or Photograph South Side of Test Pit	
5	1			Gray-brown, SILT (ML); moist to wet (seeping at base); trace fine sand; abundant organics (roots, woody debris), especially near base contact; crumbly texture.

4				-Zone of reddish brown oxidized organics with groundwater seepage at 1.6 feet bgs. Seepage flow was less than 0.5 gpm. Sharp lower contact.					
3				Olive-brown, mottling ELASTIC SILT (MH); moist to wet (seeping at local cracks); trace fine sand; medium plasticity; little organics (roots and woody debris); massive, crumbly to tight structure.		$O_w$ TP-4-S1			
2				-Gradational contact, approximately 0.5 feet thick, at 3.8 feet bgs.					
1				Gray, SILTY SAND (SM); moist to wet (local seepage); fine sand; trace organics (woody debris); massive.					
0						TP-4-S2	WC=32% FC=49%
