# Stratum Group Report Summary

October 16, 2024

**Re: Alluvial Fan Geology Assessment**  
West Big Lake  
Skagit County, WA

This geologic assessment was conducted to assess an alluvial fan and watershed on the west side of Big Lake in Skagit County, Washington. Numerous flood events have been reported on this alluvial fan. The most recent flood took place in November 2021. Flood events on the alluvial fan have been reported in 1991, 1995, 2003, 2015, 2016, and possibly in 2018. This geology assessment was conducted to provide an overview of the geology of the alluvial fan and watershed conditions relative to the alluvial fan to evaluate the potential hazards on the alluvial fan area and provide some conclusions and possible options for the alluvial fan area.

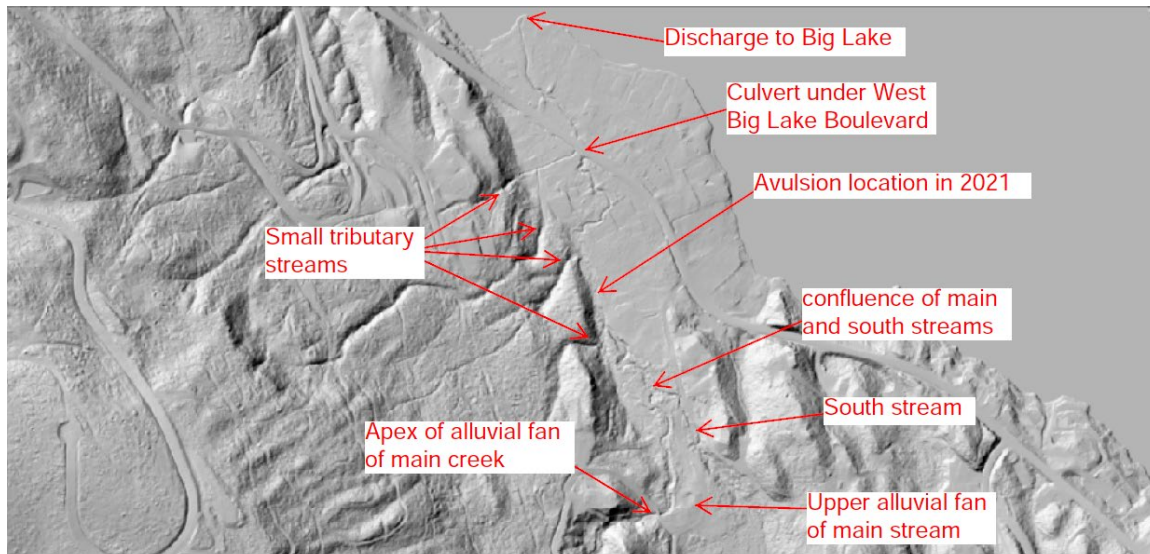
The alluvial fan is a composite fan that has been formed by sediment deposition from several streams (Figure 1). The majority of the sediment has been derived from the main creek that flows from the main stream pond/marsh. This main creek flows from west to east and has incised a canyon between the pond/marsh area and the composite alluvial fan.

Figure 1. Bare earth image of alluvial fan area

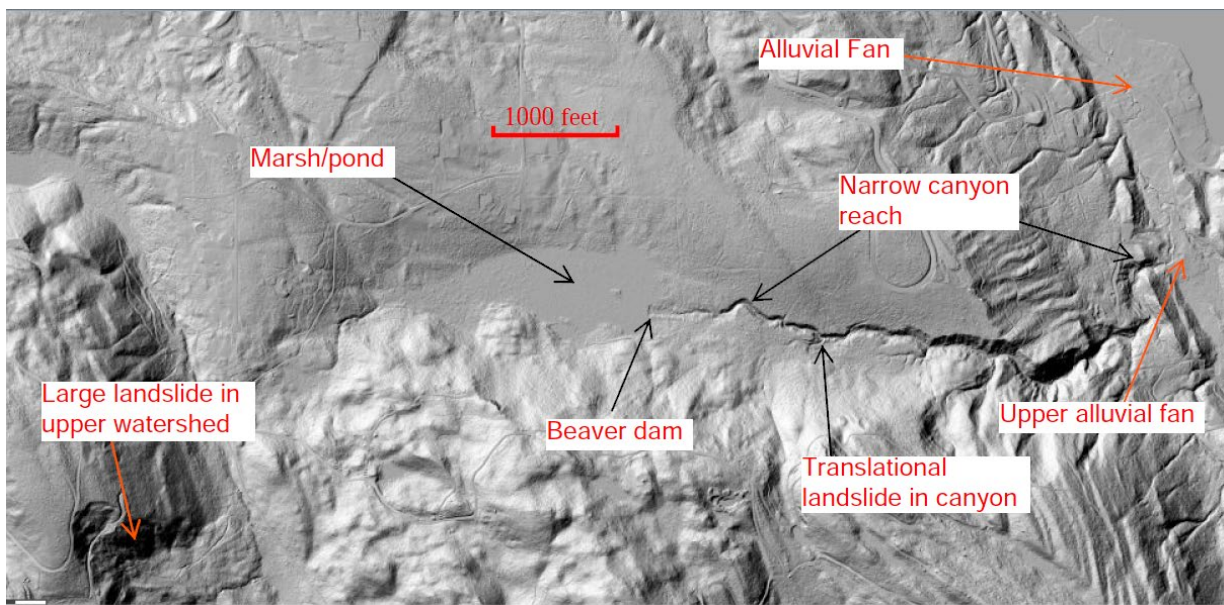
The main creek that flows drains an area of slightly more than 1 square mile above the alluvial fan area. A general overview of the watershed is provided in Figure 5.

Figure 5. Lidar bare earth imagery of main stream watershed

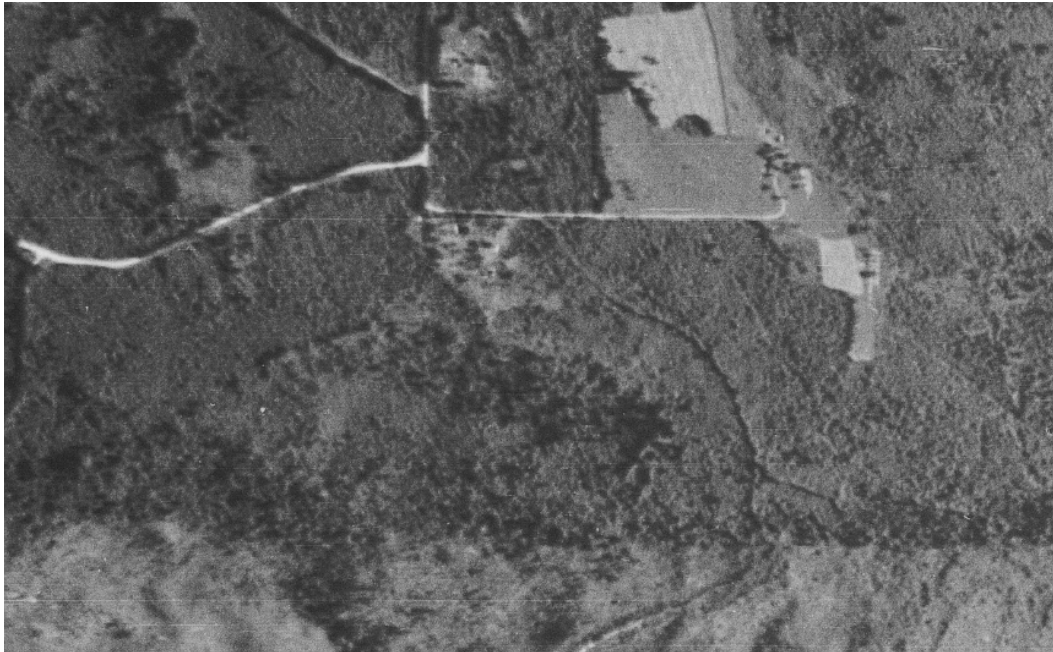
The stream outlet to the pond/marsh has been manipulated by beavers in a manner that raises the water level in the pond/marsh. This activity appears to have been taking place for many decades with water levels varying over time based on historic aerial photographs that date back to 1941 (Figure 6 and 7).

Figure 6. 1941 aerial view.

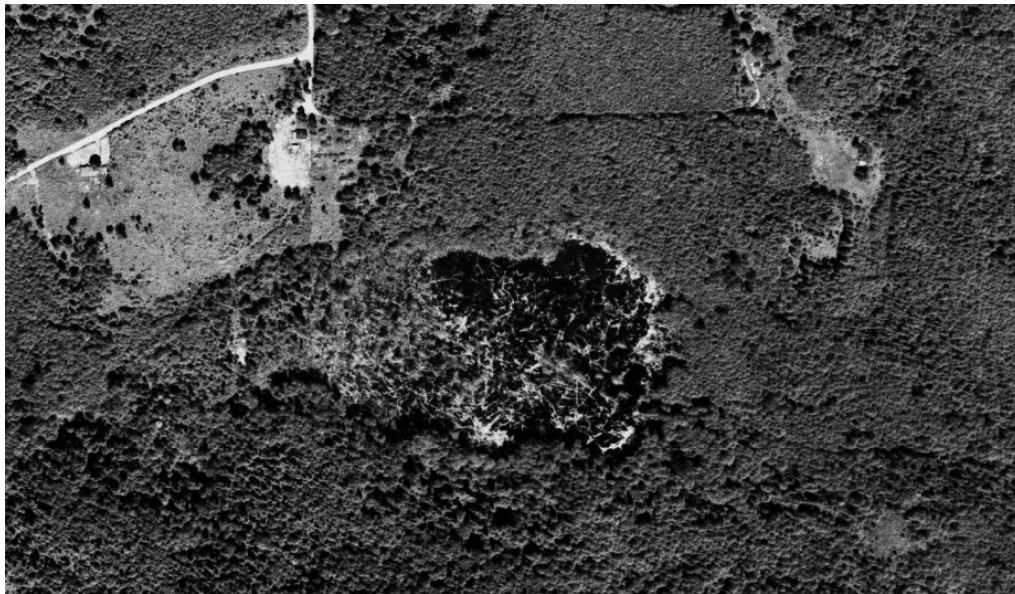
Figure 7. 1954 (USGS) aerial view of pond with larger area inundated

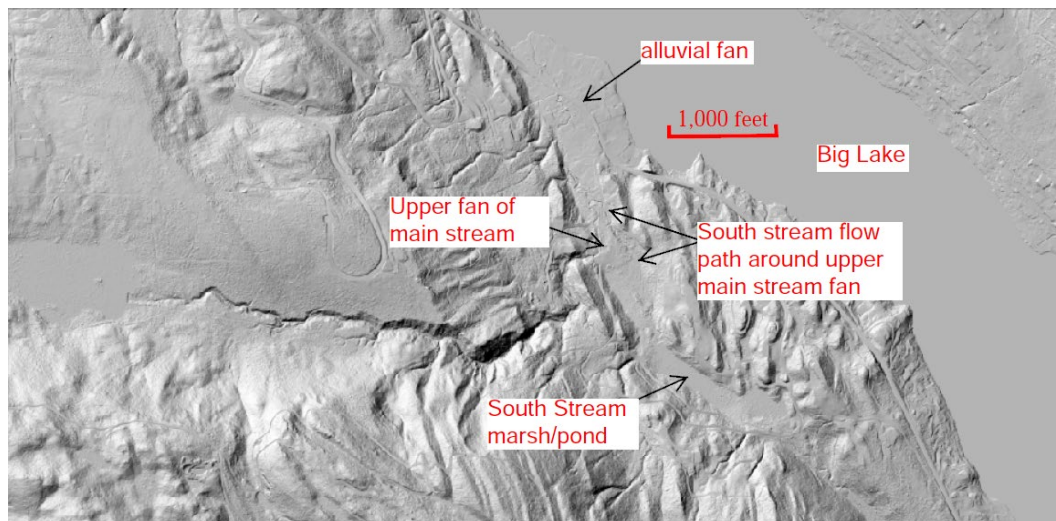
The south stream watershed is located within the strike valley that extends southward above the upper alluvial fan area (Figure 16). There is a pond/marsh in the watershed (Figure 16 and 17). The pond/marsh was not accessible, but past reports indicate that there has been and is a beaver dam located at the outlet area of the pond. Variable water levels evident in historic aerial photographs are consistent with beaver activity. The pond is approximately 2.2 acres in size. There appears to be a second marshy area with some beaver use upstream as well.

The size of the watershed and the topography of the watershed are such that flooding from the south stream will be limited to beaver dam failures. As noted above, the beaver dam was not accessible (on private property) so the conditions at the beaver dam could not be fully evaluated.

Figure 16. Lidar bare earth image of the south stream watershed and alluvial fan

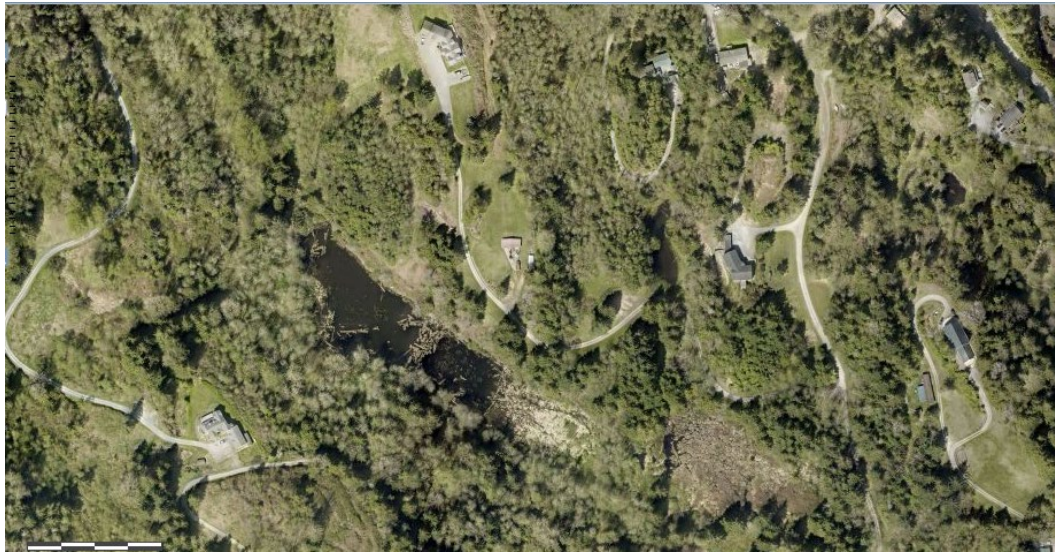
Figure 17. Aerial view of pond/marsh areas on south stream
