Samish Island Conservation Area Restoration

Feasibility Study and Conceptual Restoration Ideas Report - DRAFT

Blue Coast Engineering LLC, with contributions from
Mott Macdonald
Shannon & Wilson

August 2024

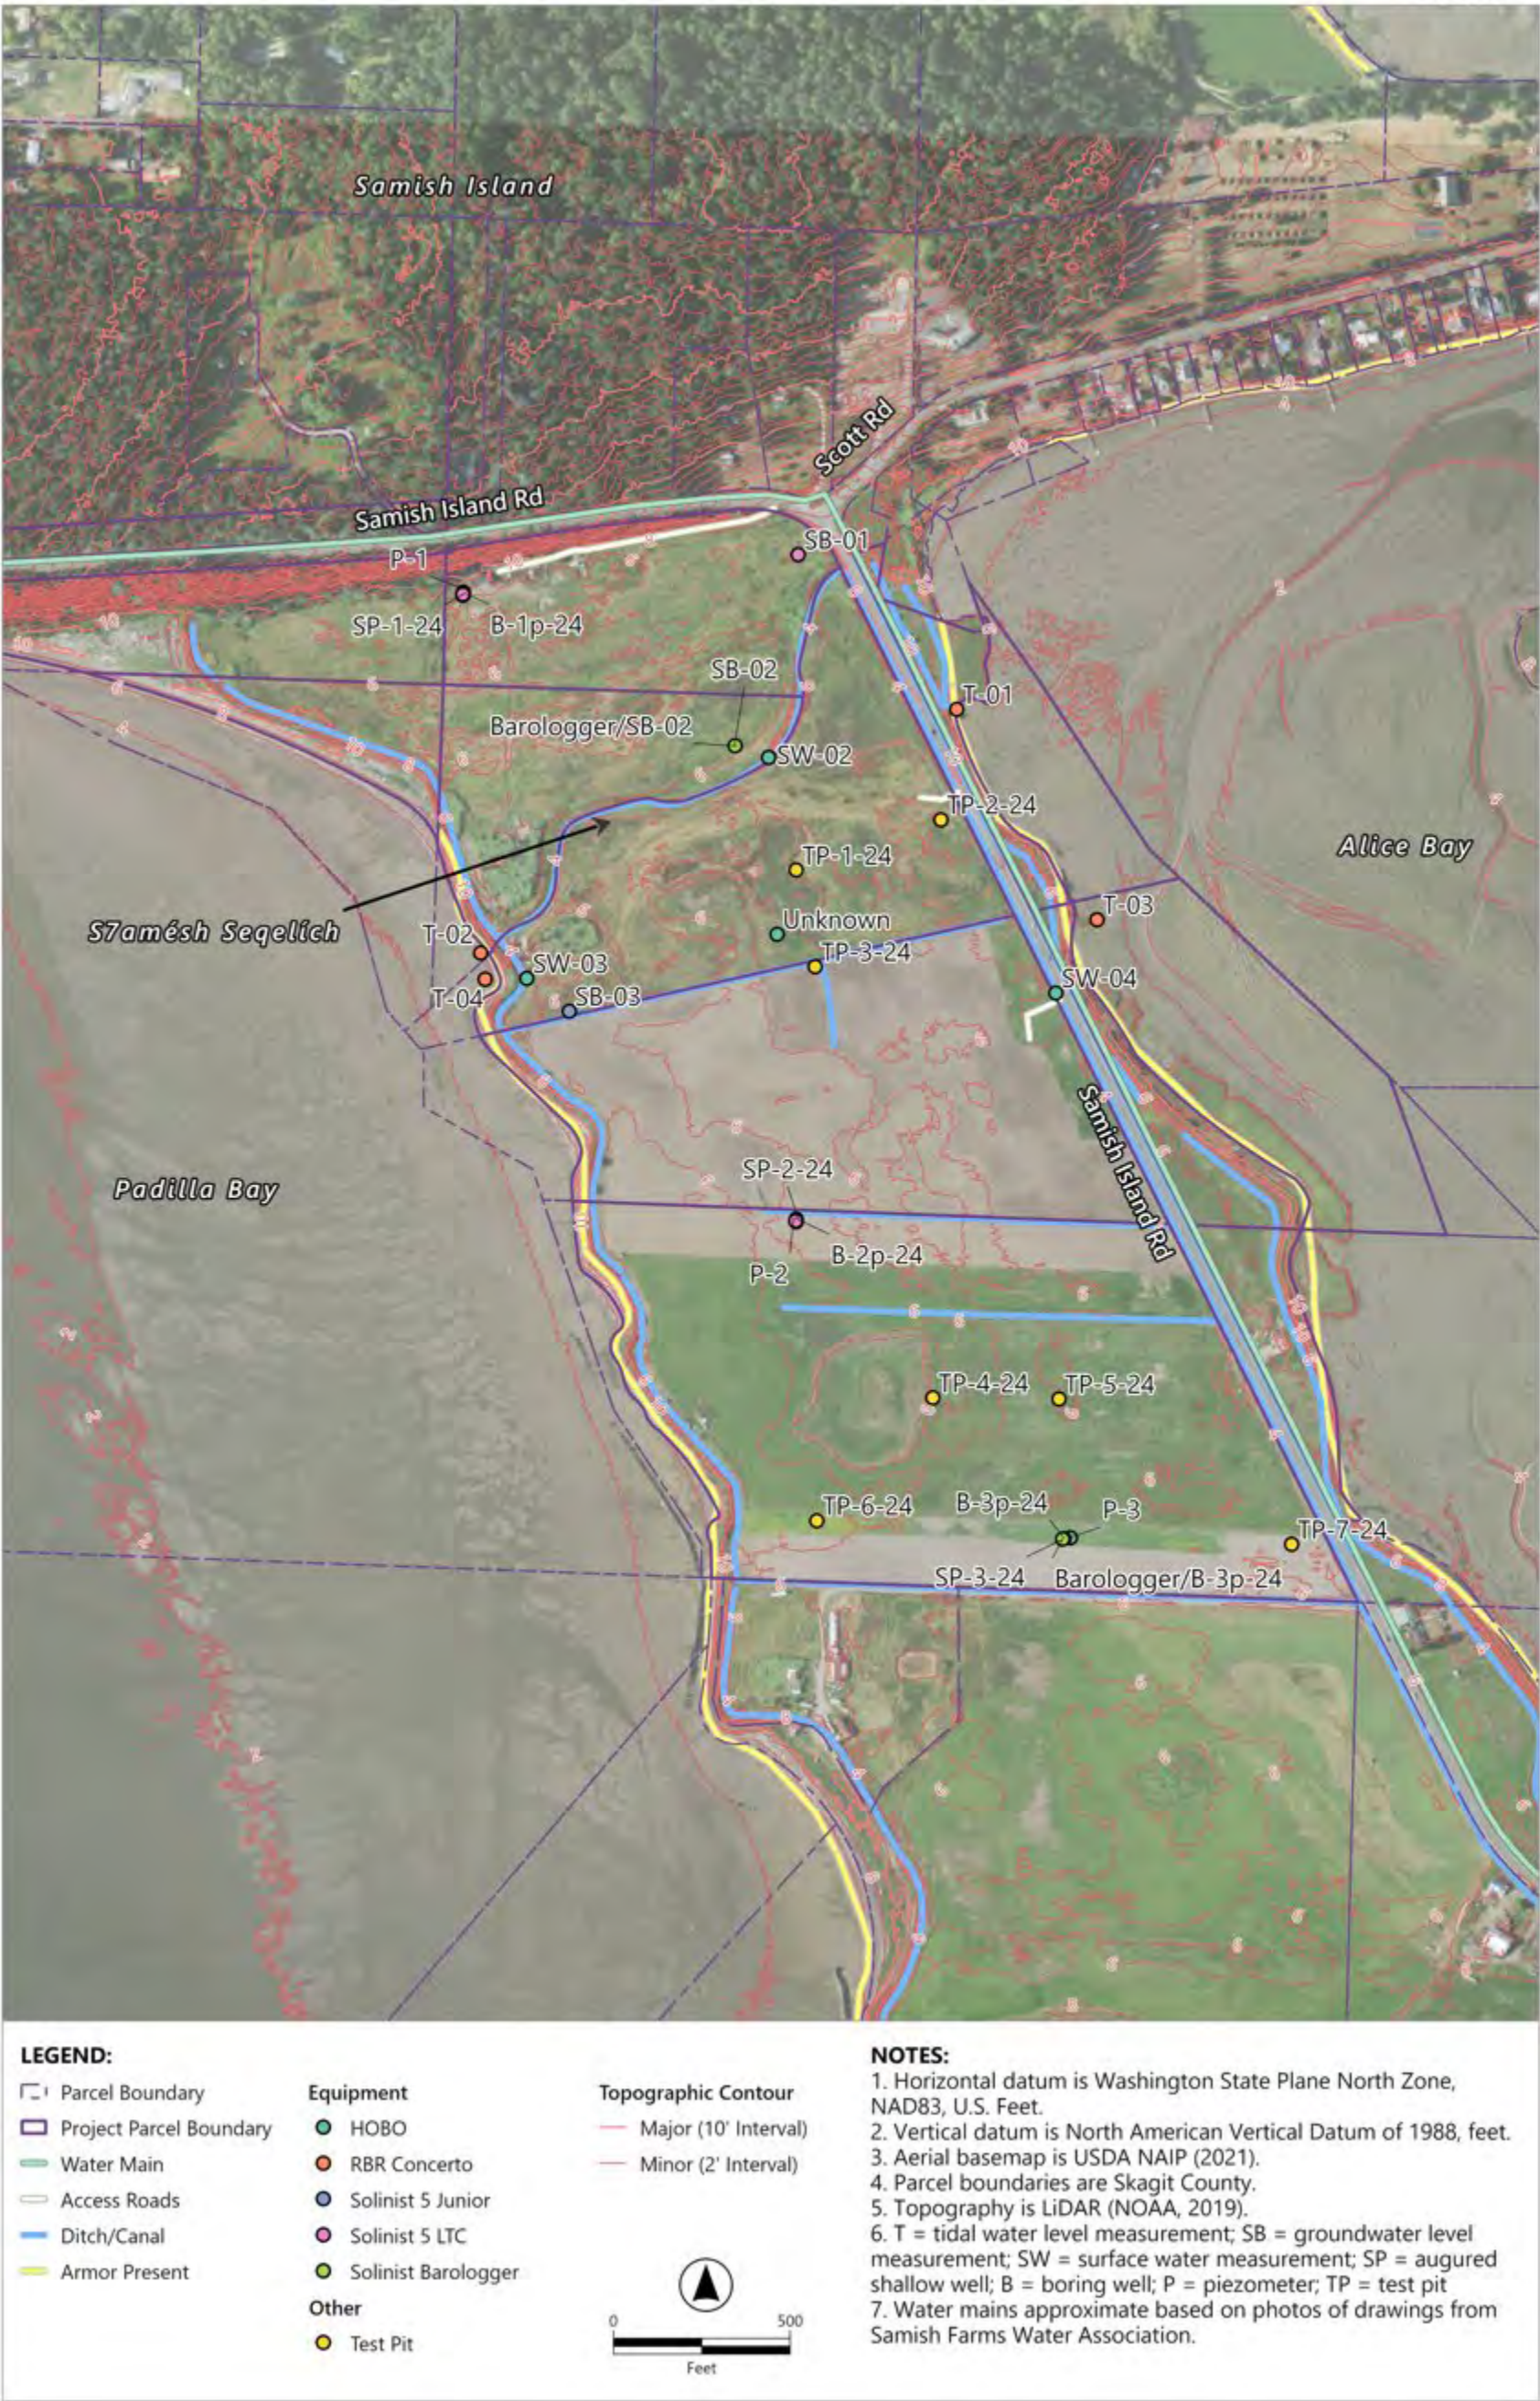
Figure 3. Samish Island Conservation Area data collection site map.

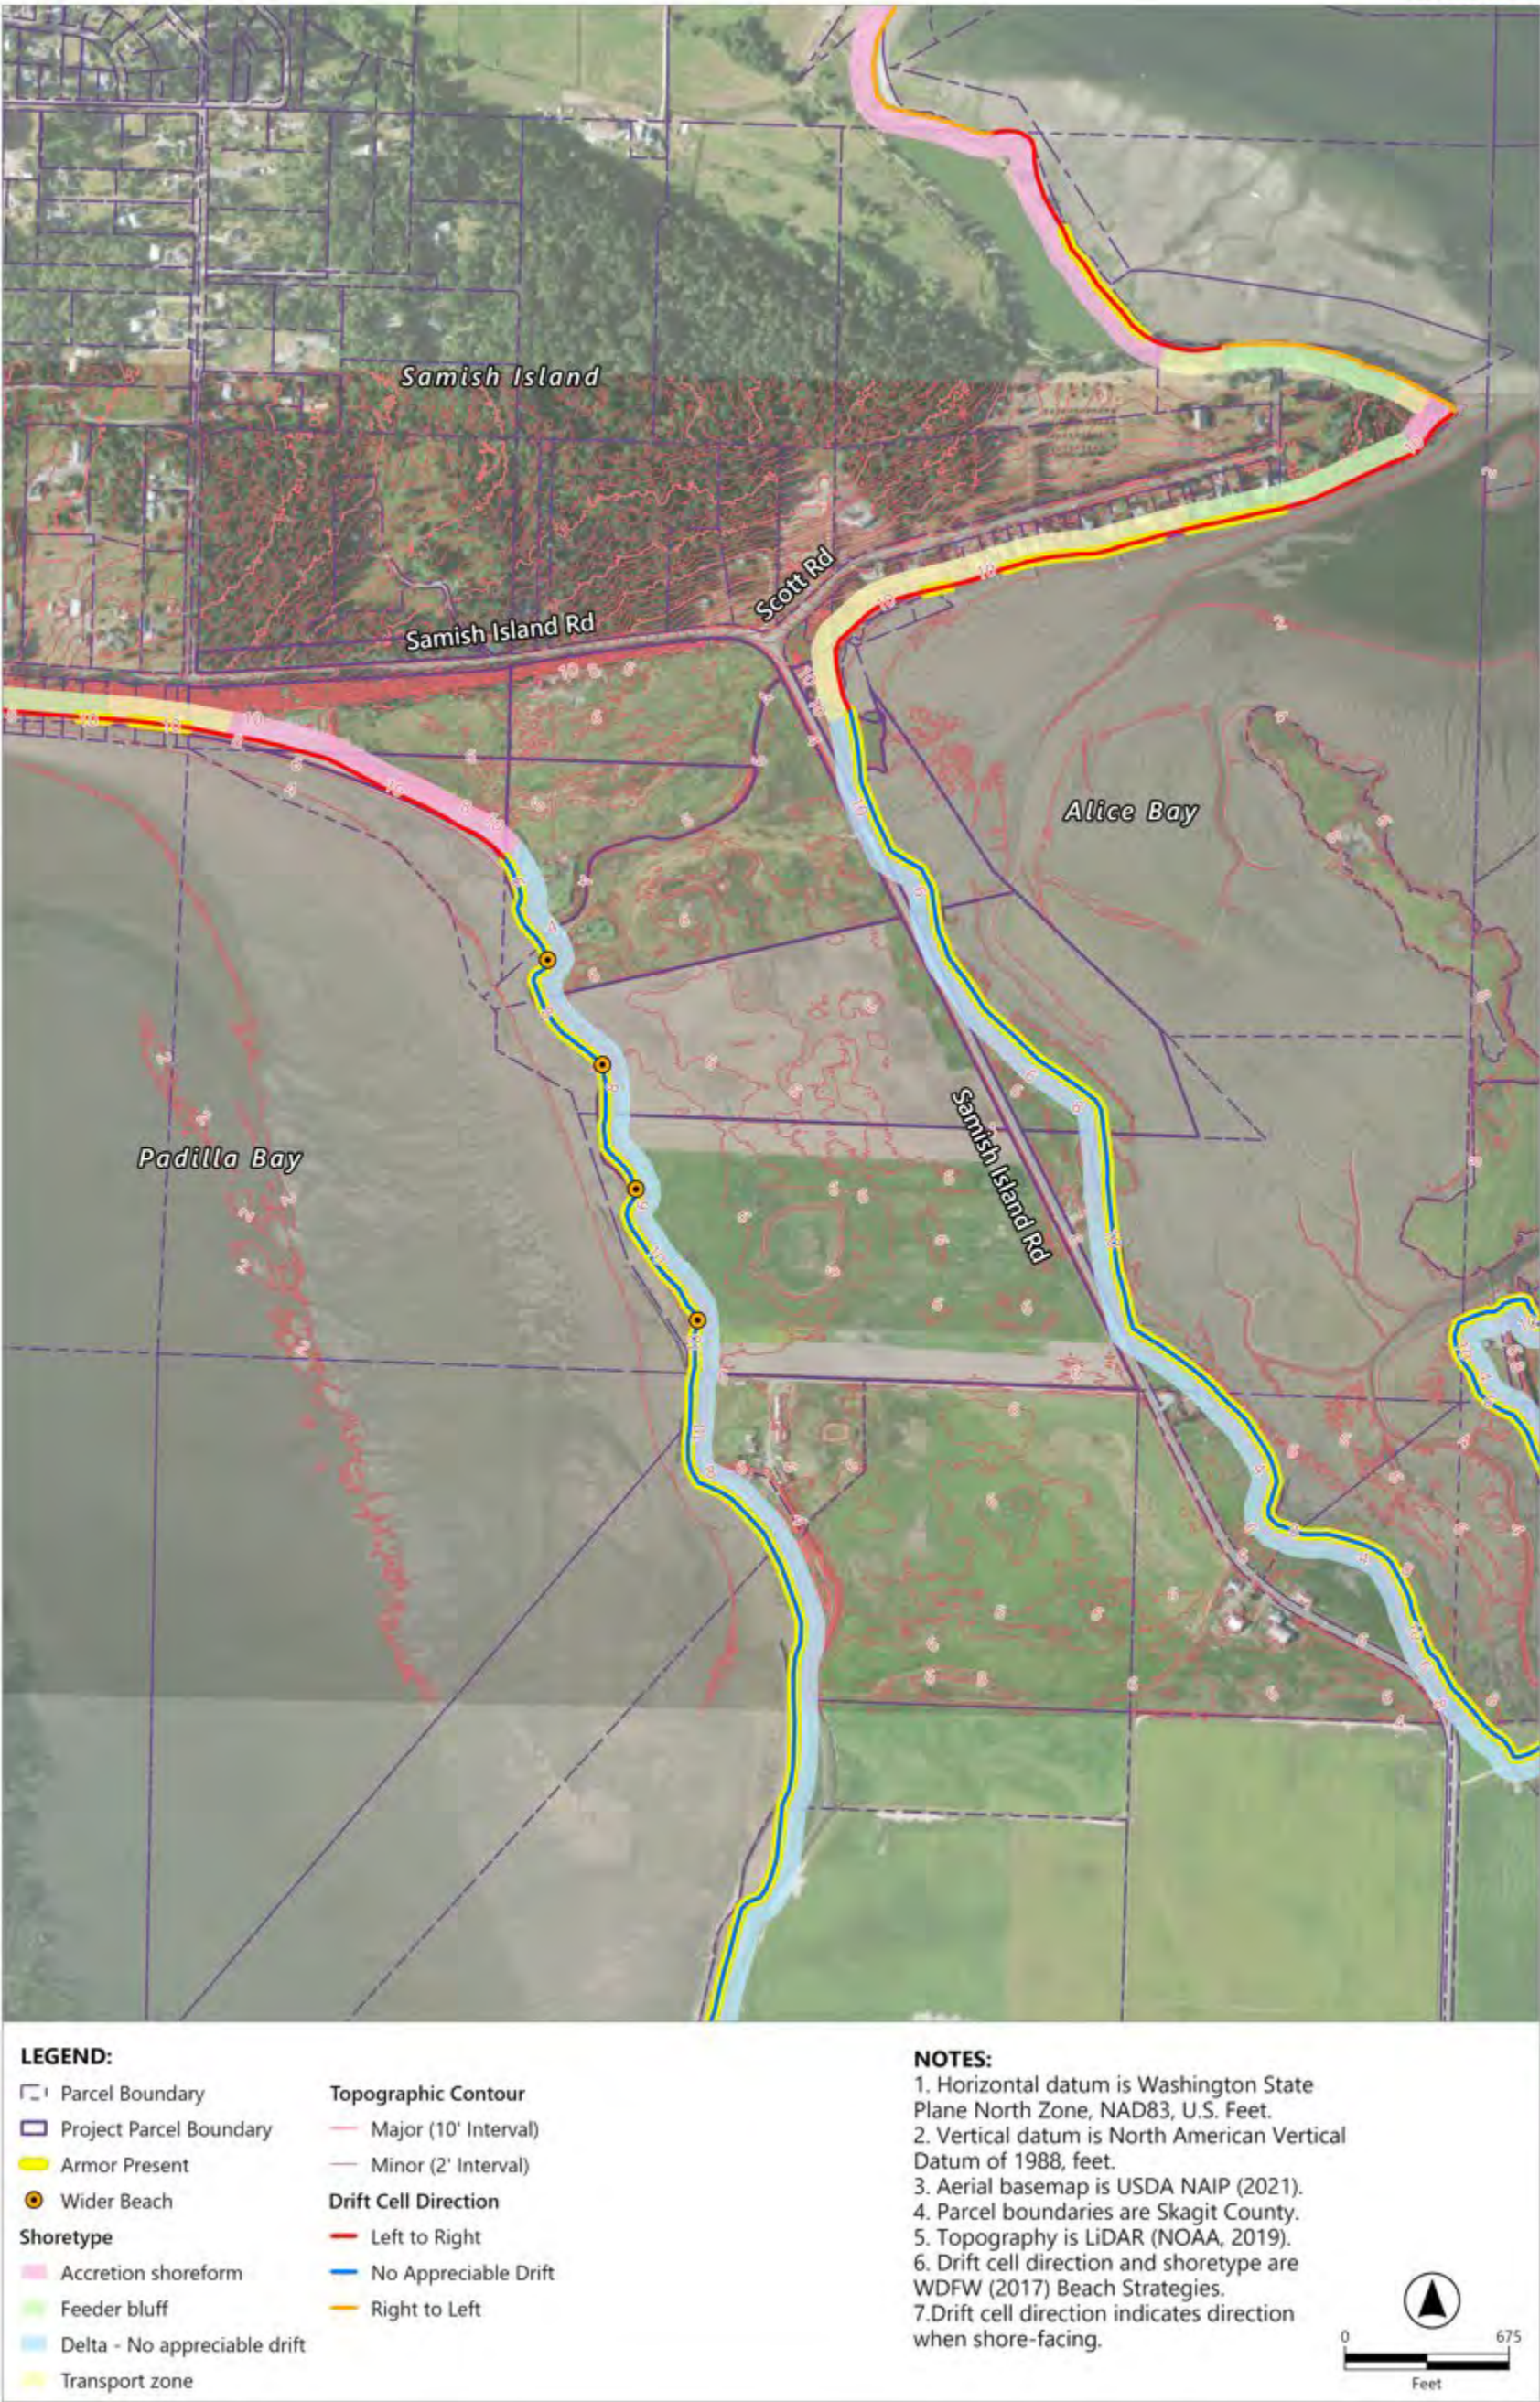
Figure 9 Samish Island coastal geomorphology map.

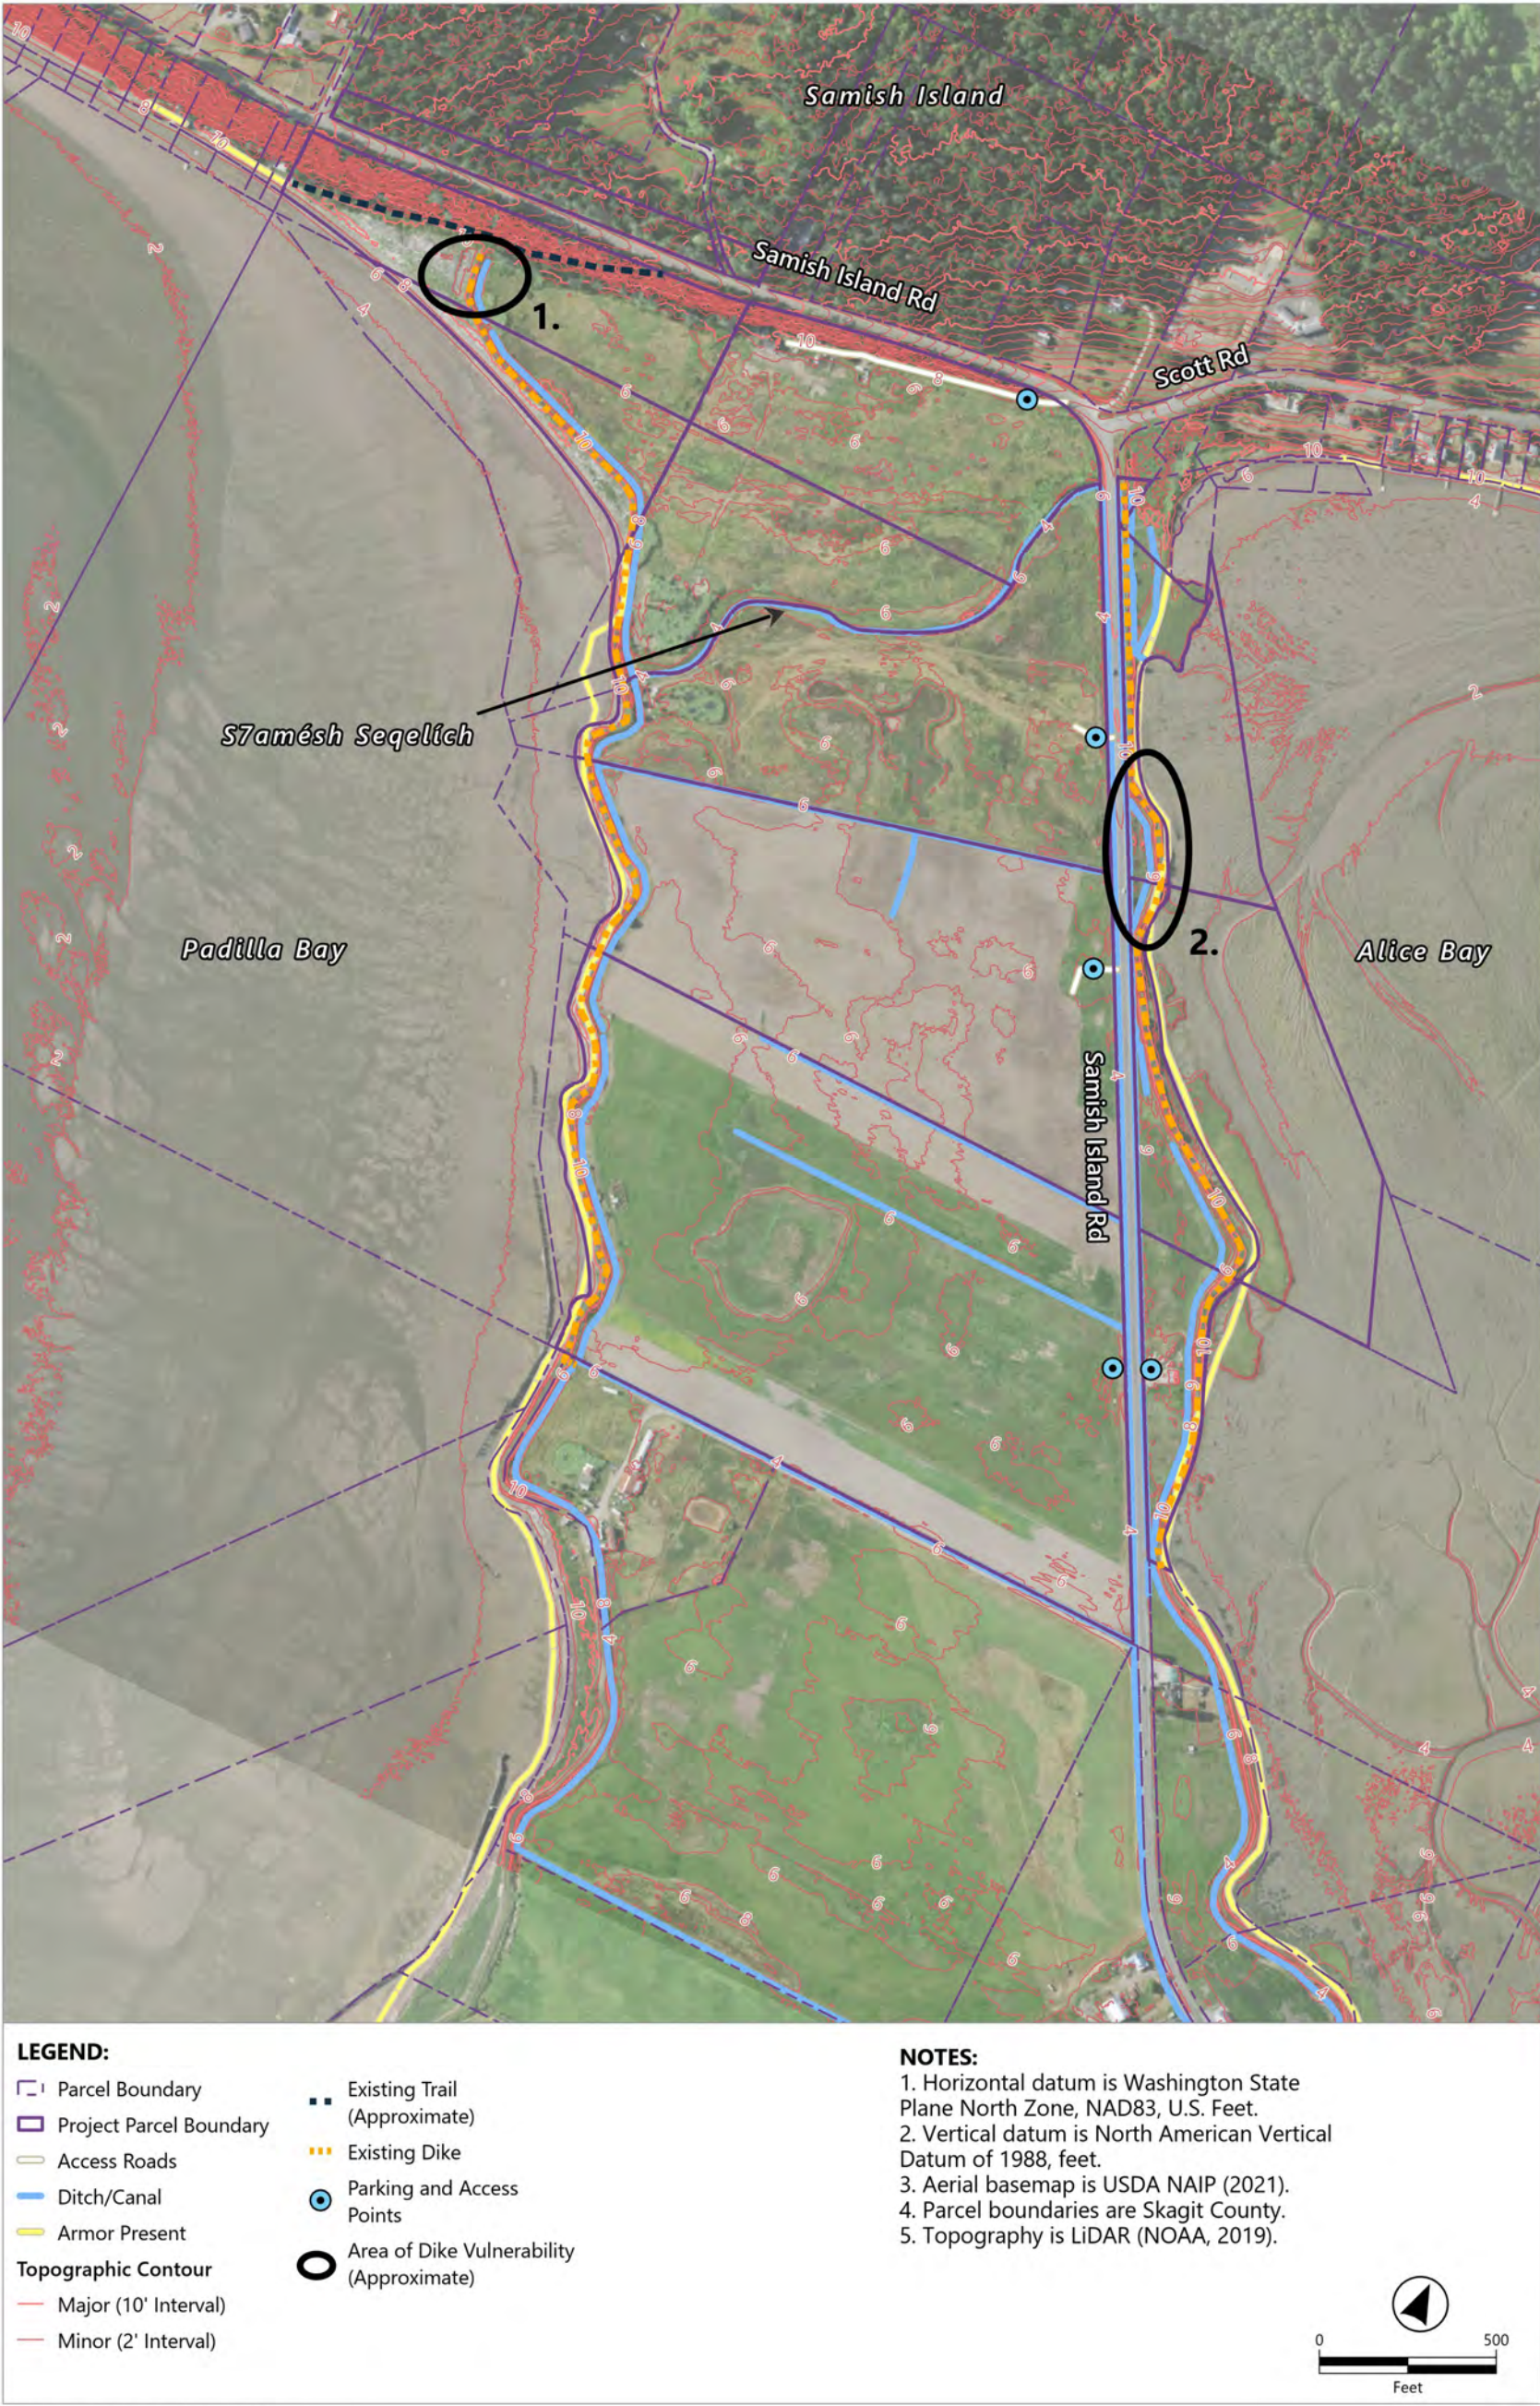
Figure 13. Restoration Concept 1 for no restoration action.

The No Restoration Action concept has been developed to demonstrate how the site would potentially evolve if a restoration project was not implemented, and other solutions were not developed for the road and dikes. The elements of a No Restoration concept are shown in Figure 13 and include the following:

- No substantive changes to the Padilla Bay and Alice Bay dikes are identified.
 - Coastal overtopping of the Padilla Bay dikes will continue to occur at water levels above 8.6 feet NAVD88, which is between MHHW and HAT (or King Tide) shown as Area 1 in Figure 13.
